Jonathan's Landing Annual Inspection Report

Prepared for:
Jim Tippet
UESI Job No. COM 2021.270

Date: 7/30/2021

On July 27/28, 2021 UESI performed an annual underwater Inspection of the (WCS) Water Control Structure located within Jonathan's Landing. This inspection included: (1) Water Blasting the interior/exterior gate, frame and 6" of head wall around gate frame. (2) Assessing the condition of the exterior/interior concrete head wall, gate frame hardware and gate seals (3) Clean and lubricate gate seals and moving parts. (4) Determine the percentage of hard and soft growth (5) Identify any sediment/debris located within culverts as well as outside the WCS. This process was preformed at (WCS) 1,2,3,4,5 and 6.

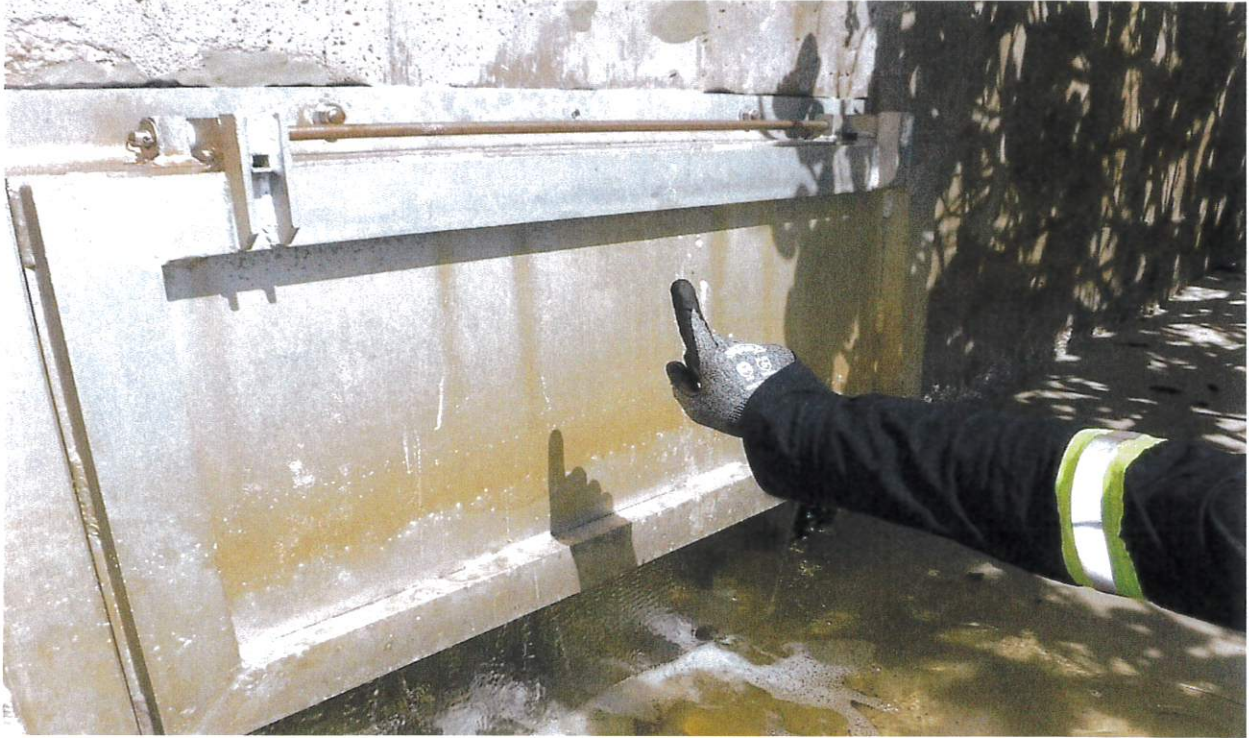
Picture shown above is the northern most gate and one of three gates at water control structure #1.

Comments
<ul style="list-style-type: none"> Upon arrival at gate #1 UESI noted no hard or soft growth on the exterior side of all three gates. The interior side located in the water box had estimated length of soft growth at ¼" with a total coverage of 30%.
<ul style="list-style-type: none"> The diver reported a sand and shall natural bottom on the gates exterior side 6" to 12" below the gate invert. On the interior side the diver noted sand sediment on the floor of the culvert box. There was an estimated 7' of freeboard from invert of gate to sediment within the culvert.
<ul style="list-style-type: none"> Located on the exterior side below the Sothern most gate. The diver noted freshwater upwelling from the sand along the headwall. The diver made entry into the culvert trying to identify the source of freshwater. Located on the eastern headwall where the southern headwall meets the eastern headwall the diver noted 24" of missing epoxy from a construction joint. The area of missing epoxy was estimated to be at the same elevation as the upwelling. The diver also noted minor pop outs and exposed aggerate. The average pop out dimensions were 1/4" diameter x 1/8" deep. The total coverage of the pop out was an estimated 5%. The estimated coverage of exposed aggerate was 5%.

<ul style="list-style-type: none"> The overall condition of the Hardware was exceptional. Very light to moderate corrosion noted. All hardware/cotter pins were present and tight.
<ul style="list-style-type: none"> The overall condition of the gate and gate frame were exceptional. Very light corrosion noted with a estimated total coverage of 3%.
<ul style="list-style-type: none"> There were no flapper gate seals present on any of the three flapper gates. The seal between headwall and gate frame appeared to be present and in good shape.

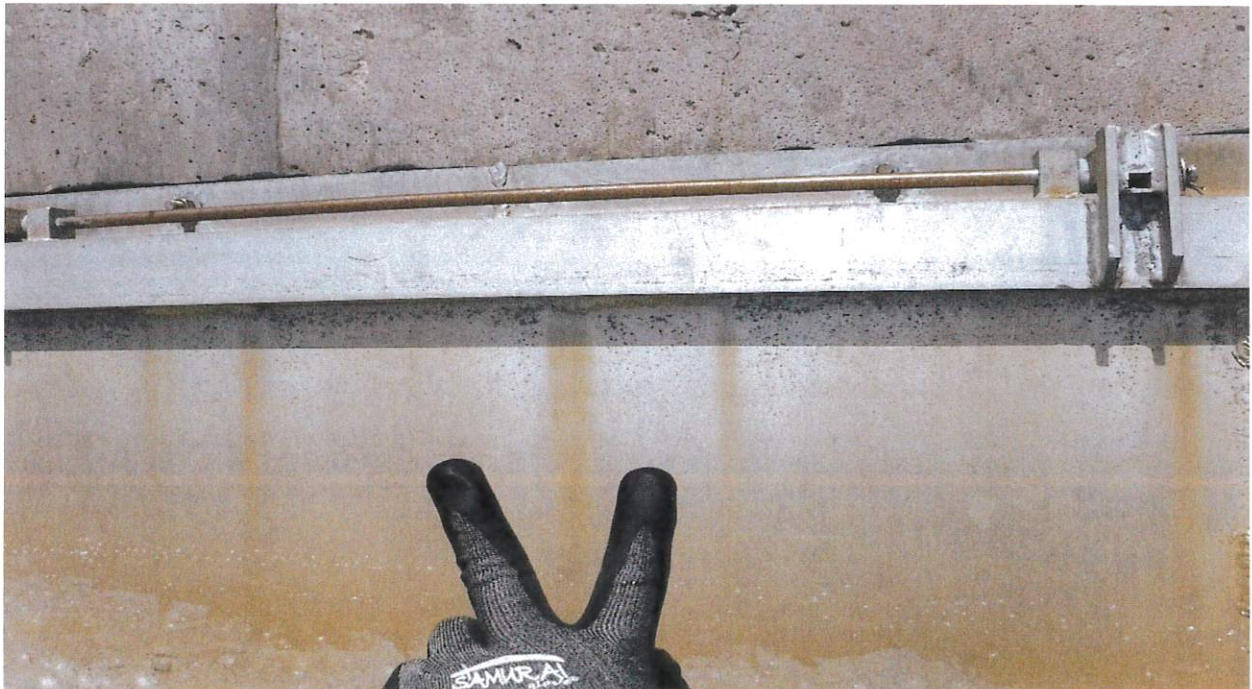
Picture shown above is the middle gate at water control structure #1

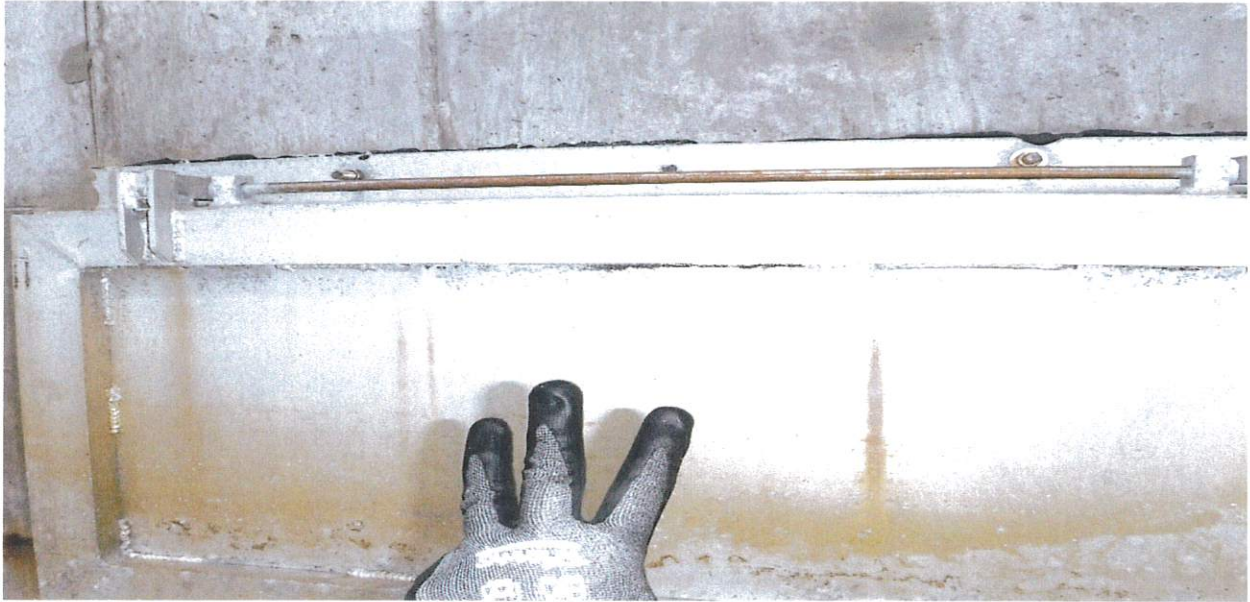
Picture shown above is the third and southern most gate at water control structure #1

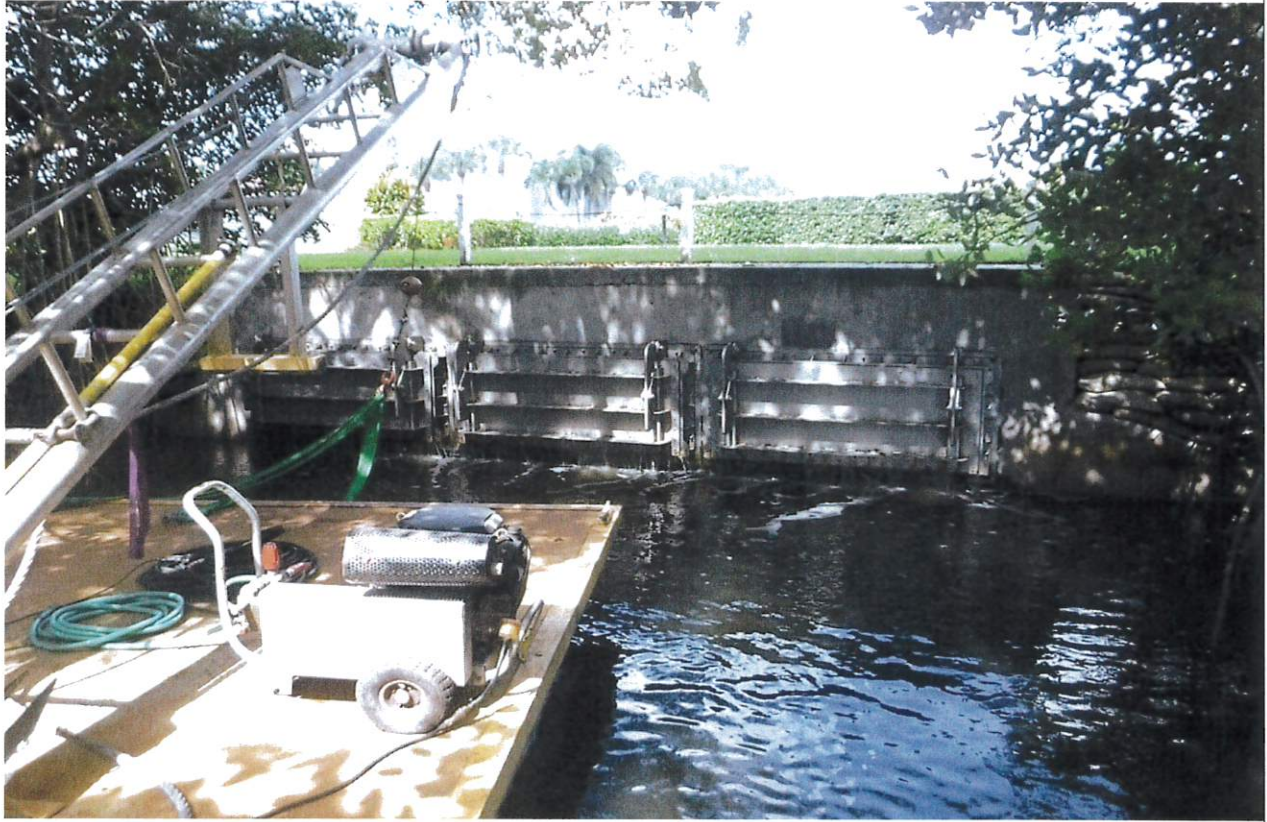
Water control structure #2

- Upon arrival at gate #2 UESI noted little to no growth on the exterior side of all three gates. Located on the interior side of the gates the diver noted an estimated coverage of soft growth at 10% with a height of 1/4" with no hard growth.

- The diver reported a sand and shell natural bottom on the gate exterior side with 4' of freeboard below the gates invert. On the interior side the diver noted 5' of freeboard from invert to sediment within culvert box.

- The overall condition of the concrete headwall appeared to be in good shape. Some minor pop outs were noted on the interior and exterior. The average pop out dimensions were 1/4" diameter x 1/8" deep. The total coverage of the pop out was an estimated 5%. There was no indication of cracking or spalling noted. Also noted was a 12"X 6" concrete repair above the northern most gate. Repair appeared to be in sound.

- The overall condition of the Hardware was exceptional. Very light to moderate corrosion noted. All hardware/cotter pins were present and tight.
- The overall condition of the gate and gate frame were exceptional. Very light corrosion noted with an estimated total coverage of 5%.

- The condition of the gates seals was exceptional. Showed no indication of dry rot, splits or tearing.

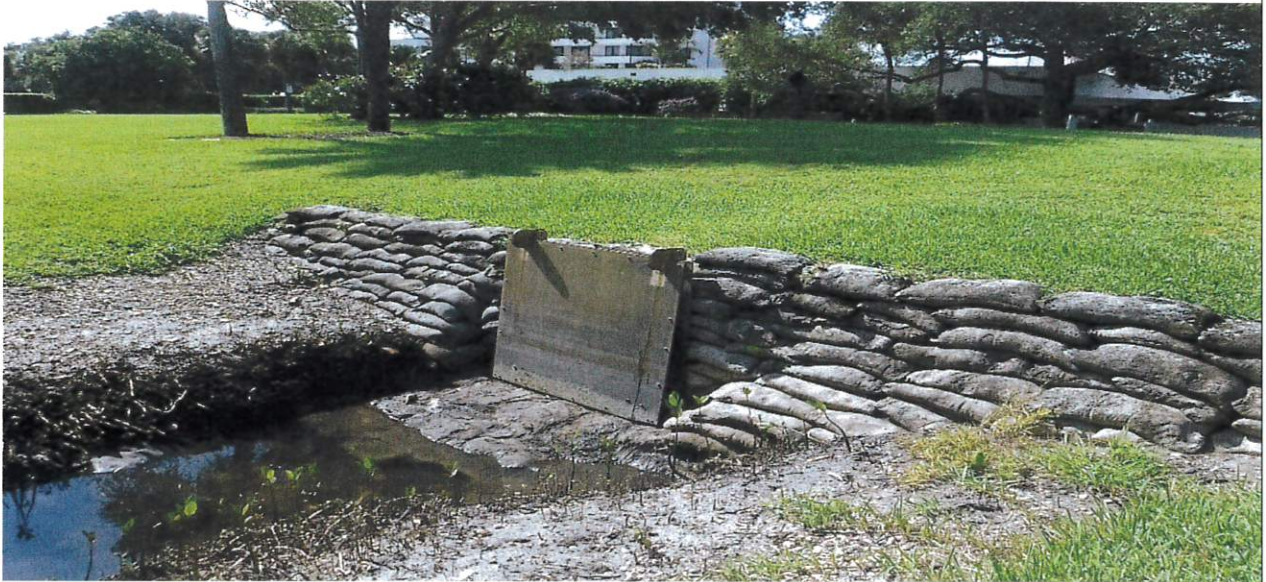
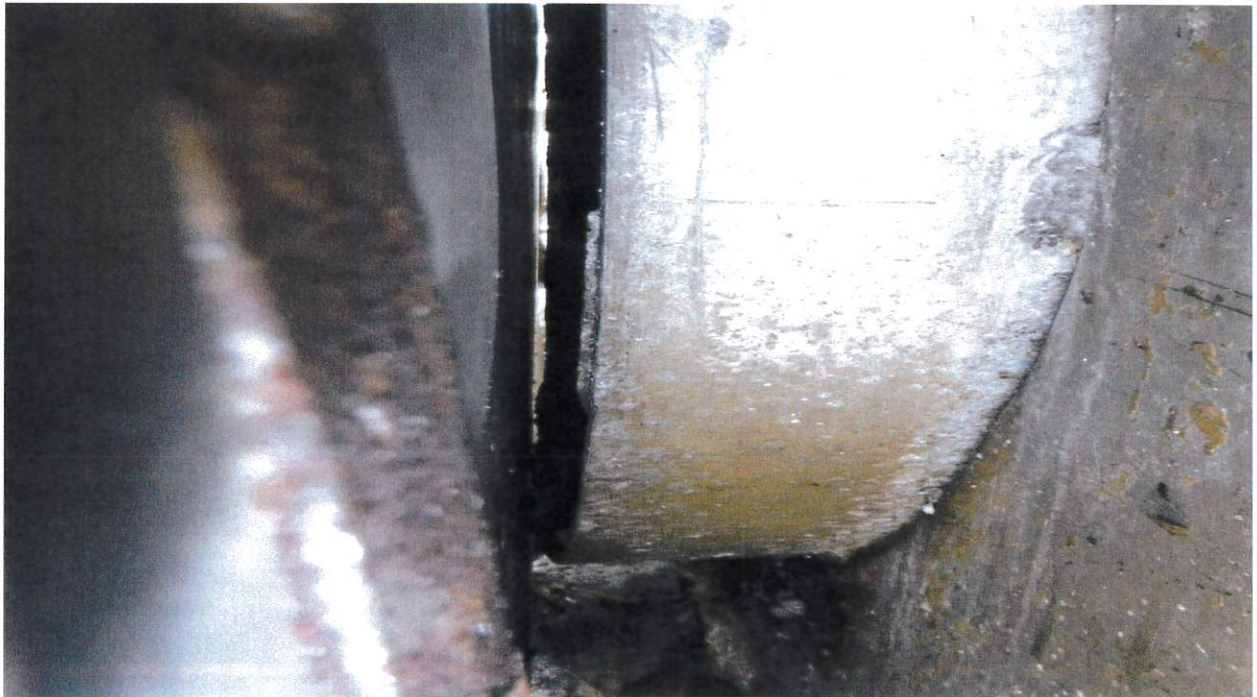
The second picture above shows gate #3 and space between the gates flapper and the gates frame. The gate flapper would not seal against the frame. The gap was an estimated $\frac{1}{4}$ " to $\frac{1}{2}$ ".

Comments
<ul style="list-style-type: none">• Upon arrival at gate #3 UESI noted no growth on the exterior/interior sides of the gate.
<ul style="list-style-type: none">• The diver reported a sand and shell natural bottom just east of the concrete apron. The exterior side had 2' of freeboard below the gates invert. On the interior side the diver noted a clean culvert with no sediment or debris.
<ul style="list-style-type: none">• The overall condition of the concrete rip rap headwall appeared to be in good shape with no reported damage. The concrete apron had approximately 6" of undermining at the leading eastern edge of the apron. There was also a small 12"X 4" spall in the same area. The diver also noted some soil erosion on the downstream side of the embankment where areas of filter fabric have become exposed.
<ul style="list-style-type: none">• The overall condition of the hardware was exceptional on the gate's flapper. Very light to moderate corrosion noted. All hardware/cotter pins were present and tight. There appears to have been a galvanized stripping used to hold the gates rubber seal into place. The galvanized stripping had heavy corrosion with total metal loss near the bottom of the gate's flapper

<ul style="list-style-type: none">• The overall condition of the gate and gate frame was poor. The gates flapper did not seal, due to the excessive amount of concrete between the slip liner and existing corrugated pipe. The only place the flapper made contact with the culvert was at the pipes invert. The remaining area the flapper had an average of ¼" to ½" gap between gate and flapper.
<ul style="list-style-type: none">• On the gate flapper is a horizontal seem with an 1/8" of separation in the rubber at approximately midpoint of the culvert. The seal showed no indication of dry rot, splits or tearing.

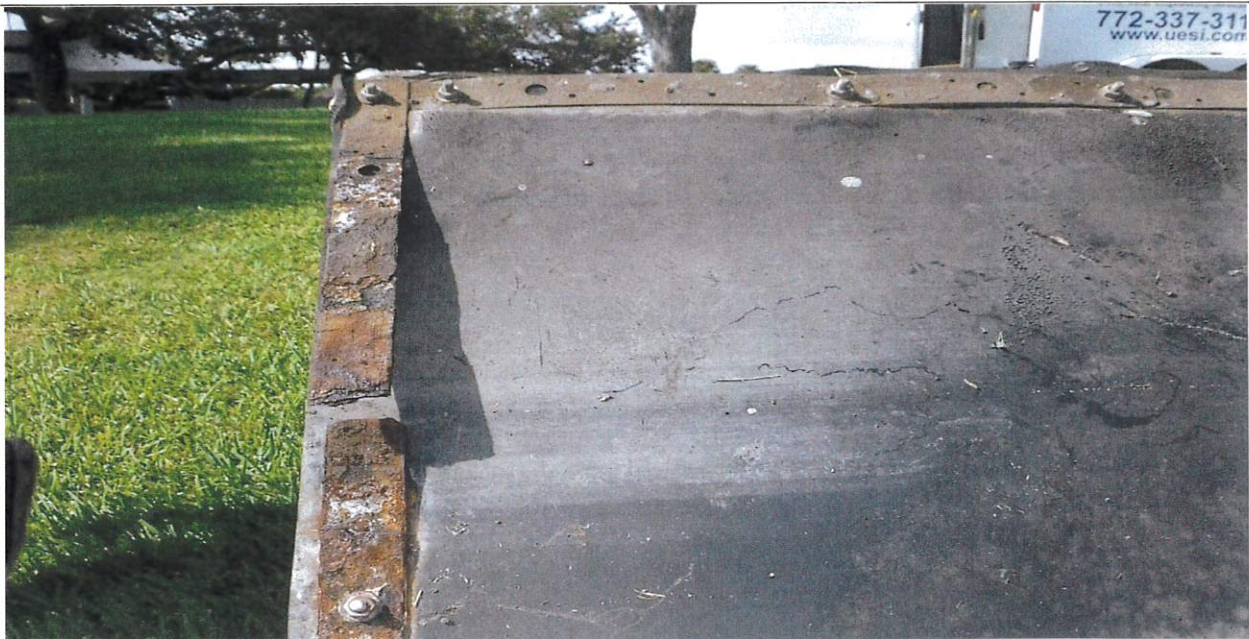
Picture above shows gate #3 interior flapper with heavy corrosion on the galvanized stripping holding seal into place.

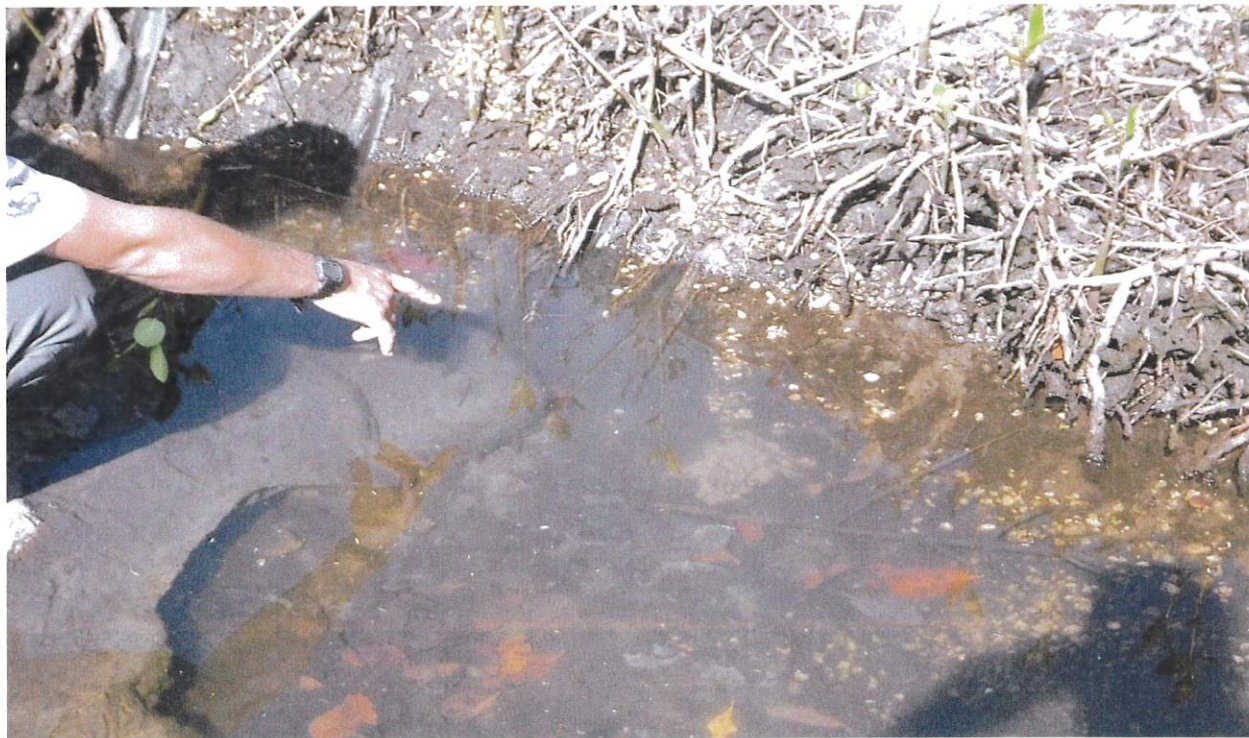
Picture above shows exposed filter fabric downstream from gate.

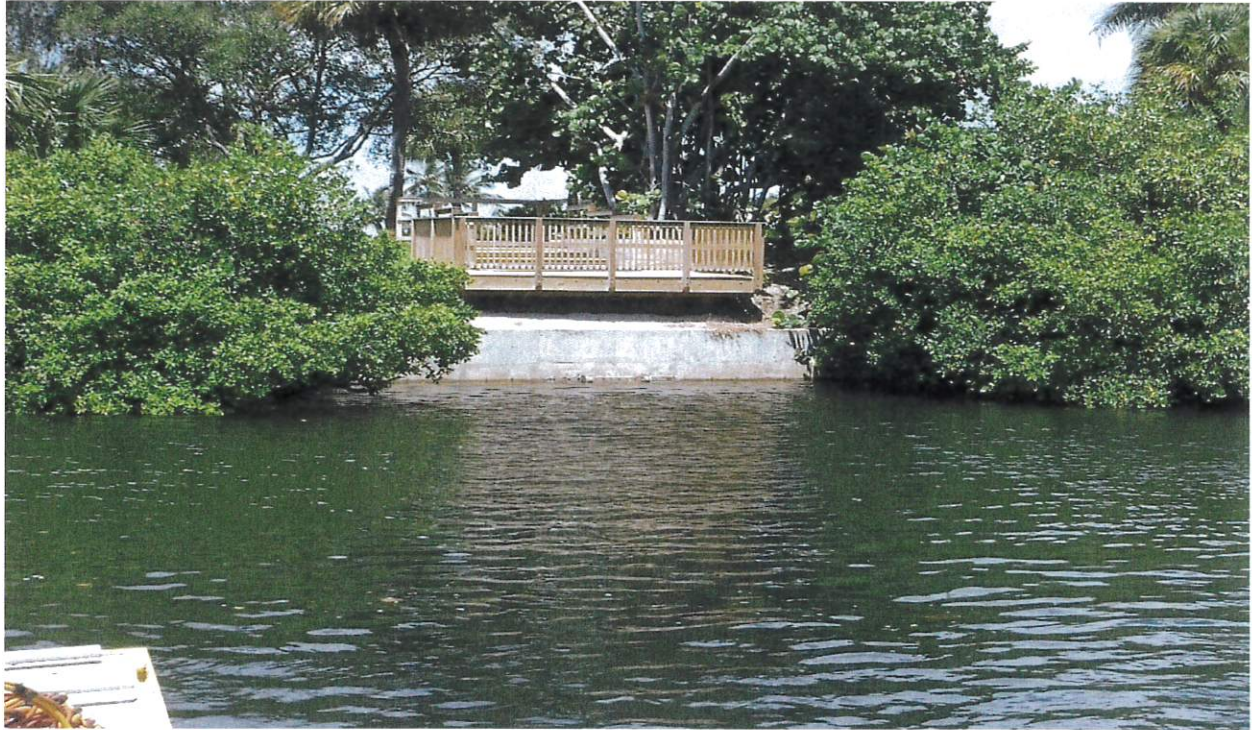
Water control structure #4

Comments
<ul style="list-style-type: none"> Upon arrival at gate #4 UESI noted very light growth on the exterior and interior of the gate. The estimated length of soft growth was ¼" and a total coverage of 60%. The estimated height of the hard growth was ¼" with a coverage of 40%
<ul style="list-style-type: none"> The diver reported a sand and shell natural bottom on the gates exterior side 2" to 4" below the gate invert. The diver noted 4" to 6" of debris and sediment inside the culvert.
<ul style="list-style-type: none"> The overall condition of the concrete headwall appeared to be in good condition. Some minor pop outs were noted. The average pop out dimensions were 1/4" diameter x 1/8" deep. The total coverage of the pop out was an estimated 5%. There was no indication of cracking or spalling on the gate side. However, the diver did note finding a section of spalled concrete just inside the pipes opening. He was unable to locate the area from which the concrete spall came from.

<ul style="list-style-type: none"> The overall condition of the hardware was exceptional. Very light to moderate corrosion noted. All hardware/cotter pins were present and tight.
<ul style="list-style-type: none"> The overall condition of the gate and gate frame were exceptional. Very light corrosion noted with an estimated total coverage of 30%.
<ul style="list-style-type: none"> The condition of the gate seal was exceptional. Showed no indication of dry rot, splits or tearing.

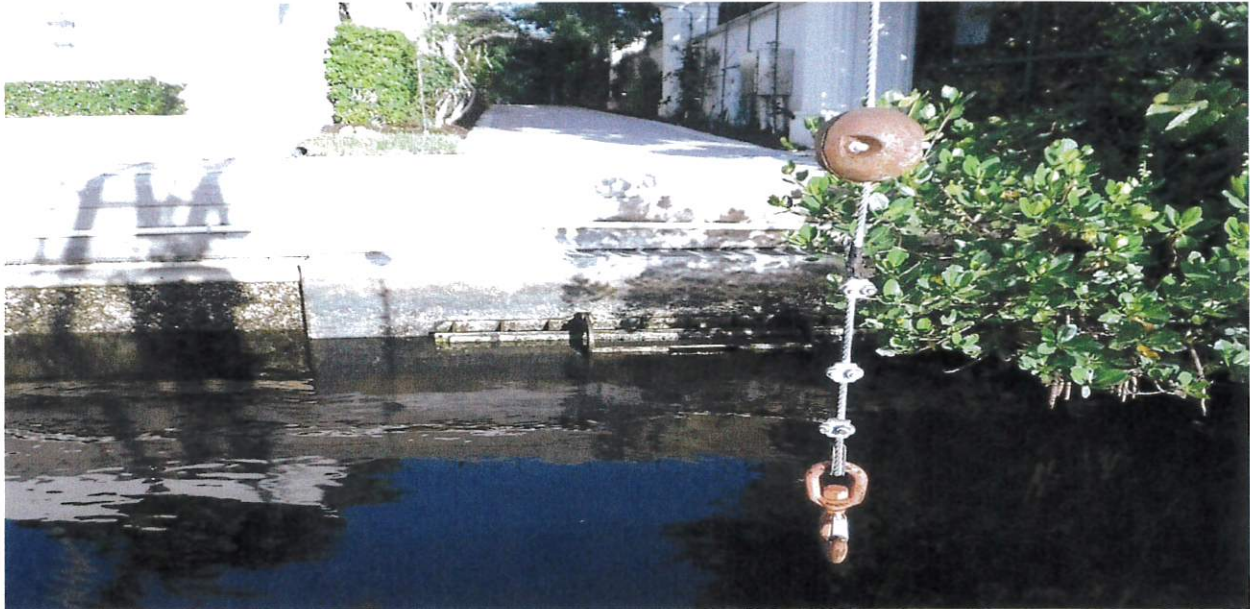
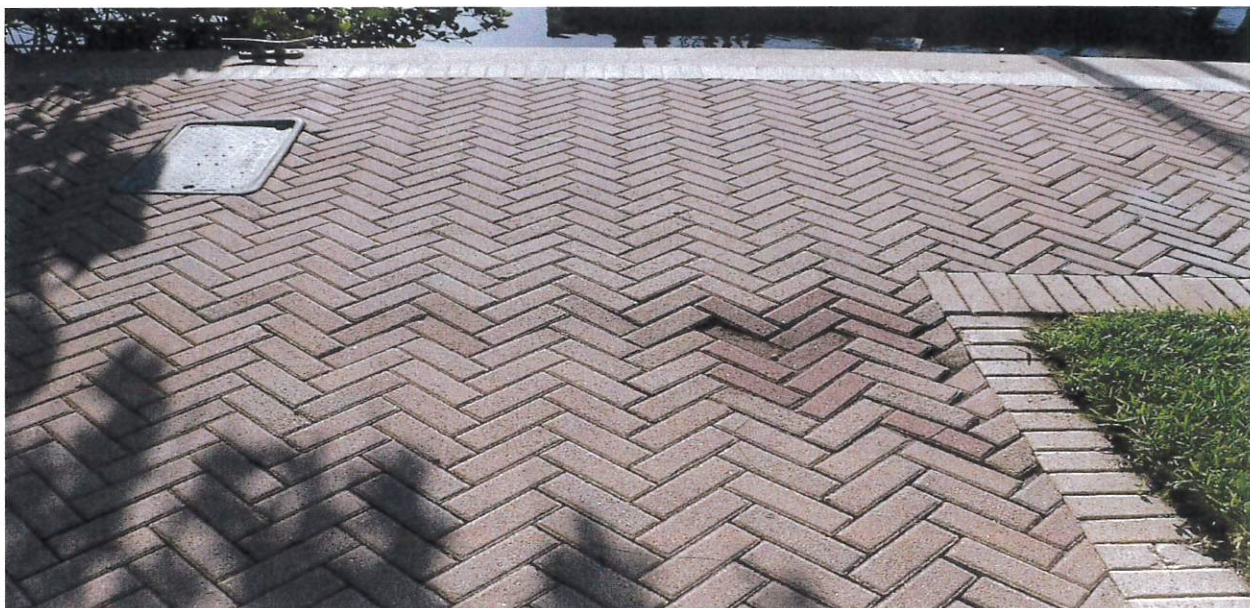
The two pictures above are of gate water control structure #5. The second picture shows the depression in the sidewalk.

Comments
<ul style="list-style-type: none"> Upon arrival at gate #5 UESI noted very little hard growth on the exterior and interior of the gate. The estimated length of soft growth was ¼" and a total coverage of 30%. The hard growth was estimated to a height of 1/4" with a total coverage of 10%
<ul style="list-style-type: none"> The diver reported a mud/sand and shell mix for natural bottom on the gate exterior side 2" to 4" below the gate invert. The dive also noted approximately 3" to 4" inside the culvert box.
<ul style="list-style-type: none"> The overall condition of the concrete headwall appeared to be in good. Some minor pop outs were noted. The average pop out dimensions were 1/4" diameter x 1/8" deep. The total coverage of the pop out was an estimated 5%. There was no indication of cracking or spalling noted. Crew noted a depression in the sidewalk approximately 6' west from exterior side of gate. The diver penetrated the culvert box and on the western most side at the first connecting culvert joint the diver found soil infiltration from the 11 O'clock position indicating joint failure.

<ul style="list-style-type: none"> The overall condition of the Hardware was exceptional. Very light to moderate corrosion noted. All hardware/cotter pins were present and tight.
<ul style="list-style-type: none"> The overall condition of the gate and gate frame were exceptional. Very light corrosion noted with a estimated total coverage of 40%.
<ul style="list-style-type: none"> The condition of the gate seal was exceptional. Showed no indication of dry rot, splits or tearing.

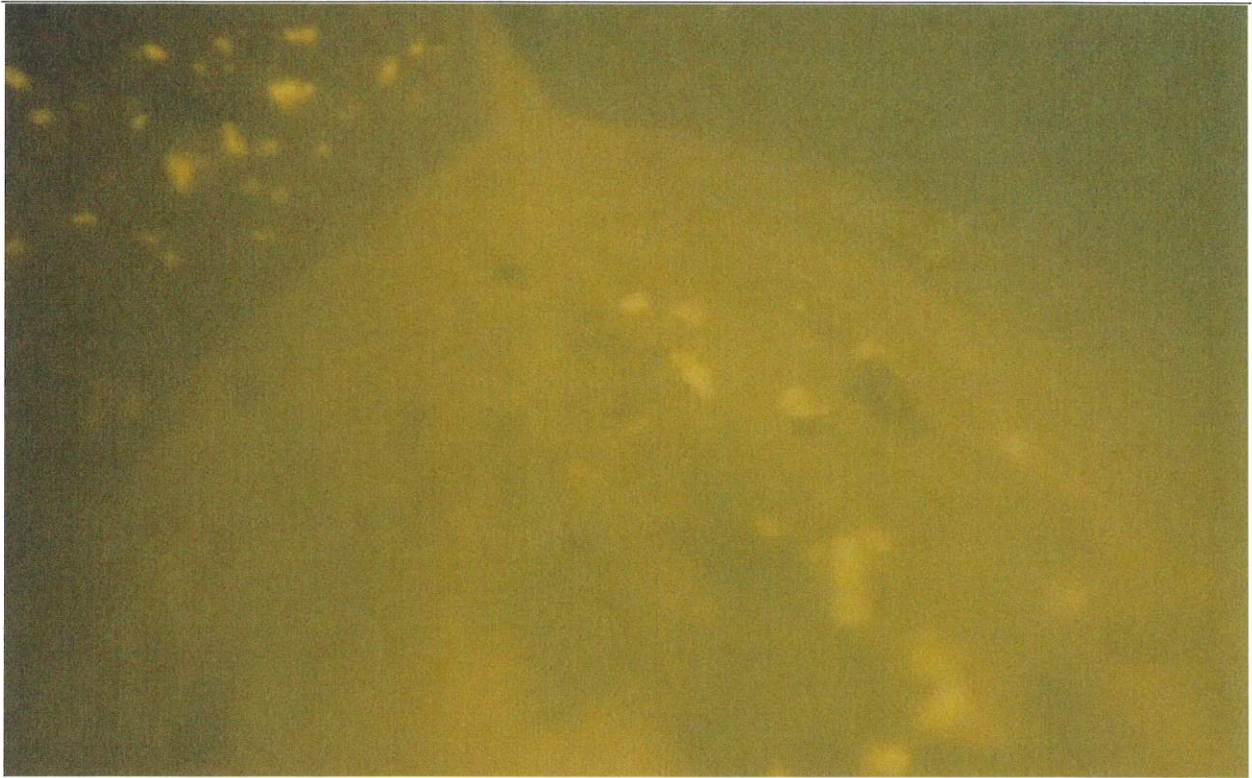
The picture above shows the soil infiltration at the first connecting to the culvert box approximately 6' west of gate #5.

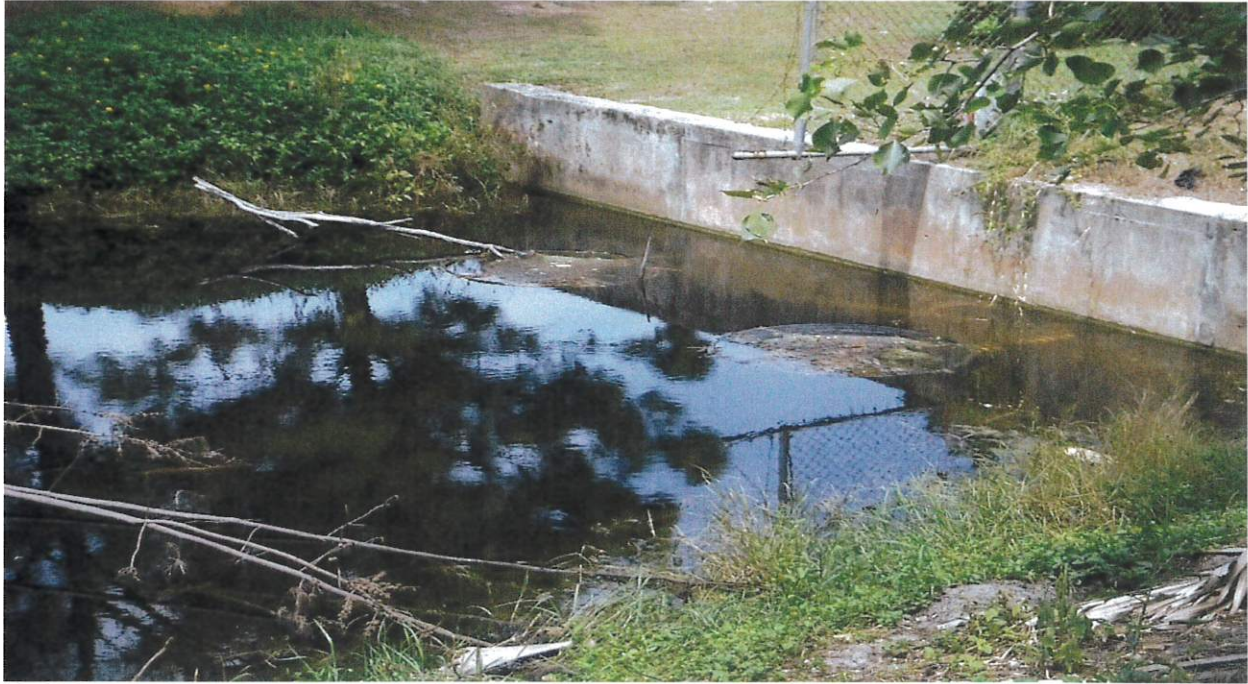
Picture above is the upstream side of water control structure #6

Comments
<ul style="list-style-type: none">• Upon arrival at water control structure #6 UESI noted very little growth on the upstream exterior and interior of the corrugated riser and head wall. located on the downstream side was typical to the upstream side with little to no growth.
<ul style="list-style-type: none">• The diver reported large amount of organic debris consisting of leaf's sticks palm fronds on the upstream side with a depth of 3' plus with approximately 12" of freeboard to top of both the northern and southern culvert riser. Natural bottom on the downstream side was estimated to be even with the invert of both the northern and southern concrete culverts. The diver also noted approximately 9" to 10" of organic debris inside both northern and southern concrete culverts.
<ul style="list-style-type: none">• The overall condition of the concrete headwall appeared to be in good condition. Some minor pop outs were noted. The average pop out dimensions were 1/4" diameter x 1/8" deep. The total coverage of the pop out was an estimated 5%. There was no indication of cracking or spalling noted.

<ul style="list-style-type: none">• The overall condition of upstream risers appeared to be in great shape. Very light corrosion noted. located on the upstream side was a flange that attached the culvert riser to the head wall. On the Southern most riser flange the diver noted one loose nut at the 12 O'clock position. The lower half of both risers had been covered with organic debris and the diver was unable it inspect due to accessibility.
<ul style="list-style-type: none">• Located just east of the culvert riser at the first culvert joint the corrugation made a transition to concrete pipe. The concrete pipe joint where an estimated 7' in length with a total of seven sections of concrete pipe on both northern and southern pipes. On the southern most pipe the largest joint gap was estimated to be 1-1/2" located at joint #3 with no sing of soil infiltration . On the northern most pipe the largest joint gap was estimated to be 2" at joint #6 working east to west. There was no soil infiltration noted at this location.

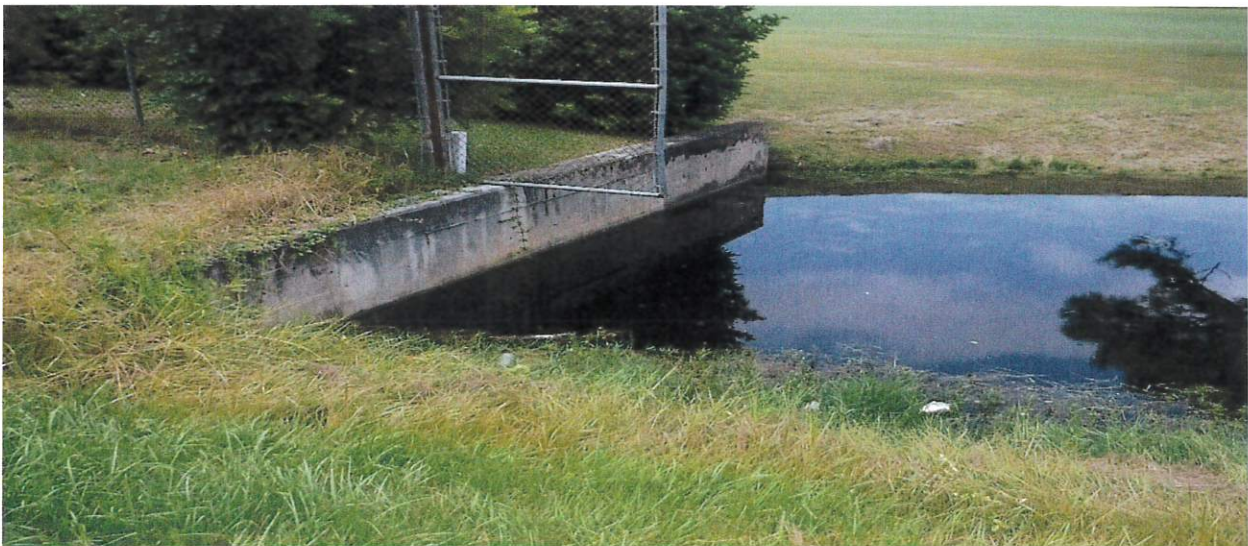
The picture above is the down stream side of water control structure #6
