Jonathan's Landing

Quarterly Inspection Report

Prepared for:
Lucas Jones
UESI Job No. COM2200054.00

Date: 02/02/2022

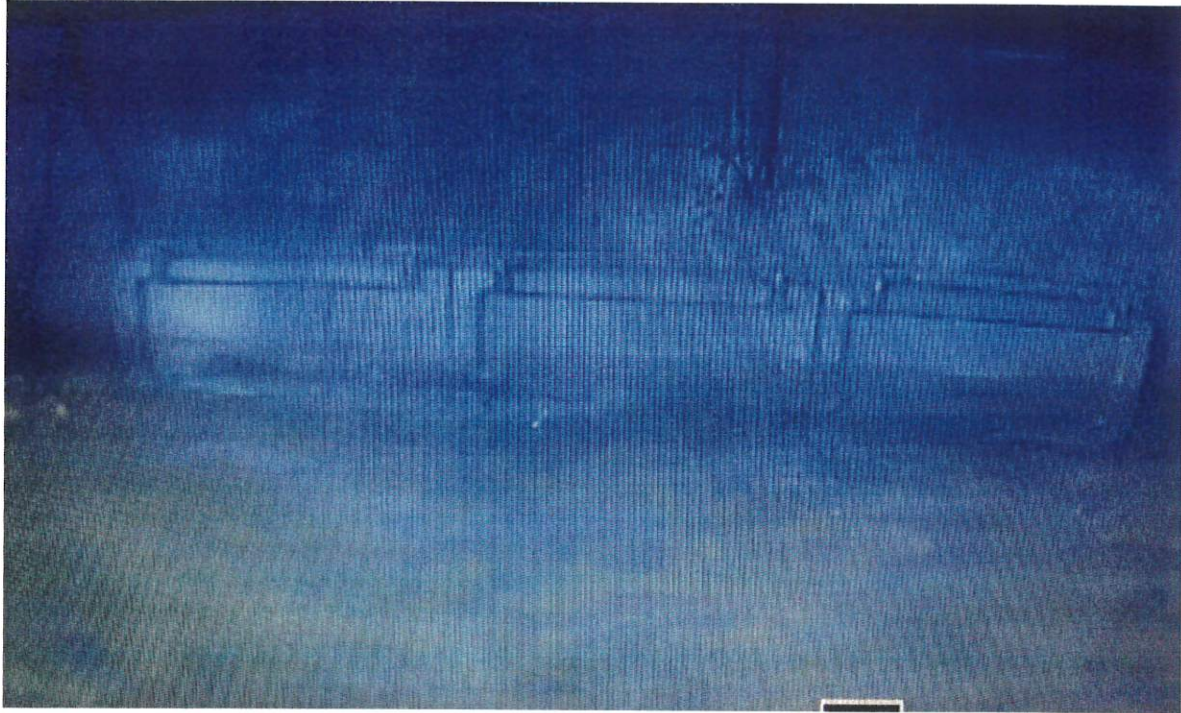
Water control structure #1

- Upon arrival at gate #1, UESI noted no hard or soft growth on the exterior side of all three gates.
- The diver reported a sand and shell natural bottom on the gates exterior side approximately 20" below the gate invert.
- The overall condition of the Hardware was exceptional. Very light to moderate corrosion noted. All hardware/cotter pins were present and tight.
- The overall condition of the gate and gate frame were exceptional.
- There were no flapper gate seals present on any of the three flapper gates. The seal between headwall and gate frame appeared to be present and in good shape.

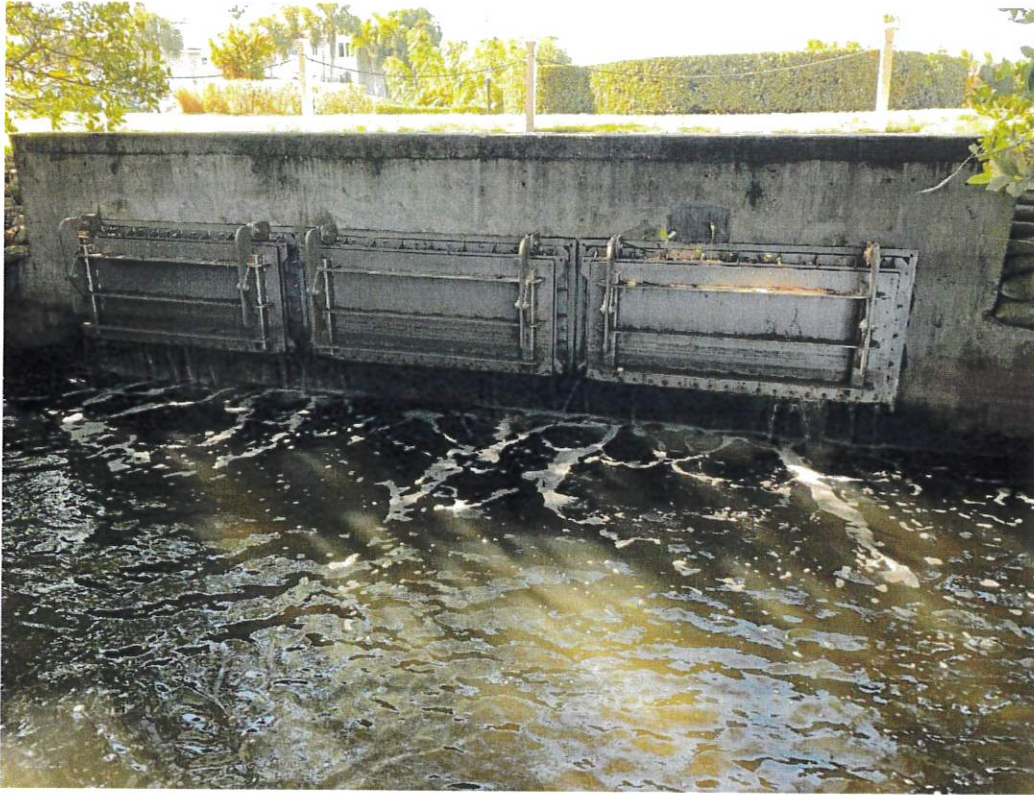
Water control structure #2

- Upon arrival at gate #2 UESI noted little to no growth on the exterior side of all three gates. Loose material and vegetation was removed by hand from the upper sections of the gates.

- The diver reported a sand and shell natural bottom on the gate exterior side with 4' of freeboard below the gates invert.
- The overall condition of the concrete headwall appeared to be in good shape. Some minor pop outs were noted on the interior and exterior. The average pop out dimensions were 1/4" diameter x 1/8" deep. The total coverage of the pop out was an estimated 5%. There was no indication of cracking or spalling noted. Also noted was a 12"X 6" concrete repair above the northern most gate. Repair appeared to be in sound.

- The overall condition of the Hardware was exceptional. Very light to moderate corrosion noted. All hardware/cotter pins were present and in place.
- The overall condition of the gate and gate frame were exceptional. Very light corrosion noted with an estimated total coverage of 5%.

- The condition of the gates seals was exceptional. Showed no indication of dry rot, splits or tearing.

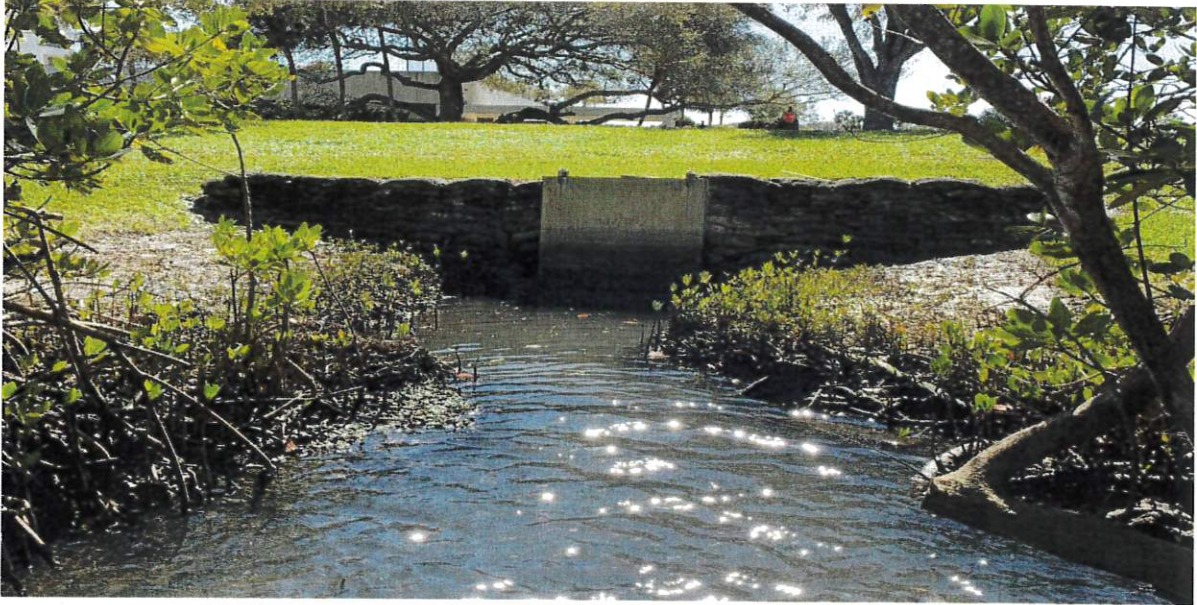
Water control structure #3

Comments:
<ul style="list-style-type: none">• Upon arrival at gate #3 UESI noted no growth on the exterior/interior sides of the gate.
<ul style="list-style-type: none">• The diver reported a sand and shell natural bottom just east of the concrete apron. The exterior side had 2' of freeboard below the gates invert. On the interior side the diver noted a clean culvert with no sediment or debris.
<ul style="list-style-type: none">• The overall condition of the concrete rip rap headwall appeared to be in good shape with no reported damage. The concrete apron had approximately 6" of undermining at the leading eastern edge of the apron. There was also a small 12"X 4" spall in the same area. The diver also noted some soil erosion on the downstream side of the embankment where areas of filter fabric have become exposed.
<ul style="list-style-type: none">• The overall condition of the hardware was exceptional on the gate's flapper. Very light to moderate corrosion noted. All hardware/cotter pins were present and tight.

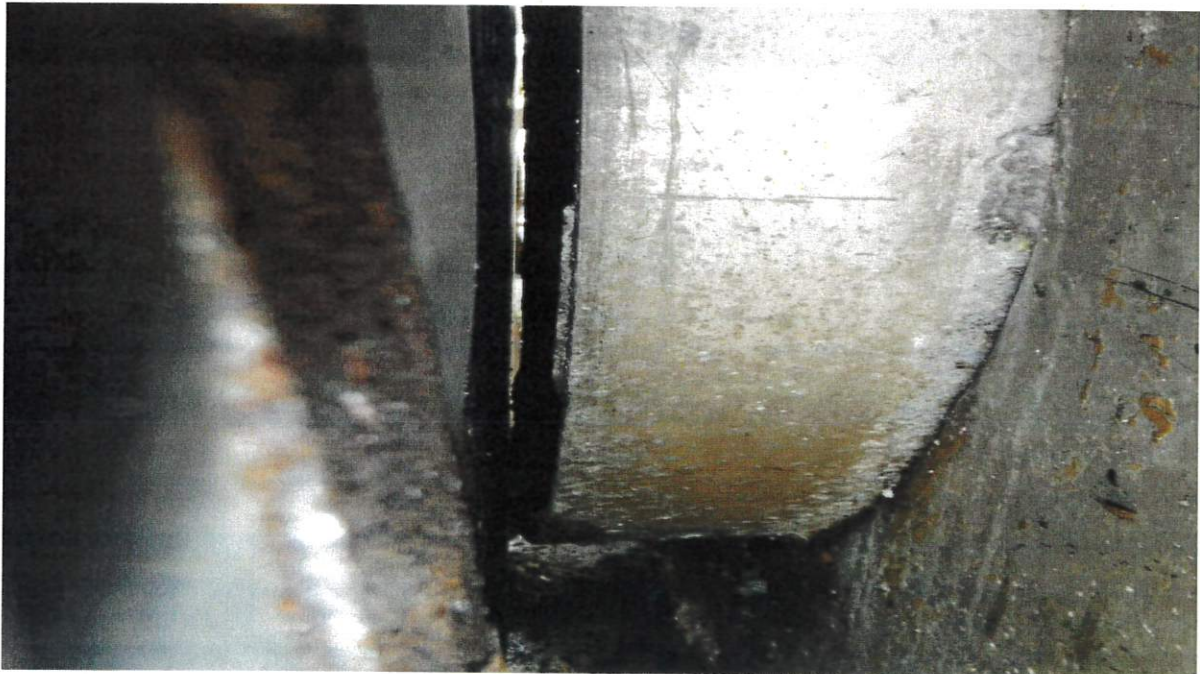
The second picture above shows gate #3 and space between the gate's flapper and the gates frame. The gate flapper would not seal against the frame. The gap was an estimated $\frac{1}{4}$ " to $\frac{1}{2}$ ".

<ul style="list-style-type: none">• The overall condition of the gate and gate frame was poor. The gates flapper did not seal, due to the excessive amount of concrete between the slip liner and existing corrugated pipe. The only place the flapper made contact with the culvert was at the pipe's invert. The remaining area the flapper had an average of ¼" to ½" gap between gate and flapper.

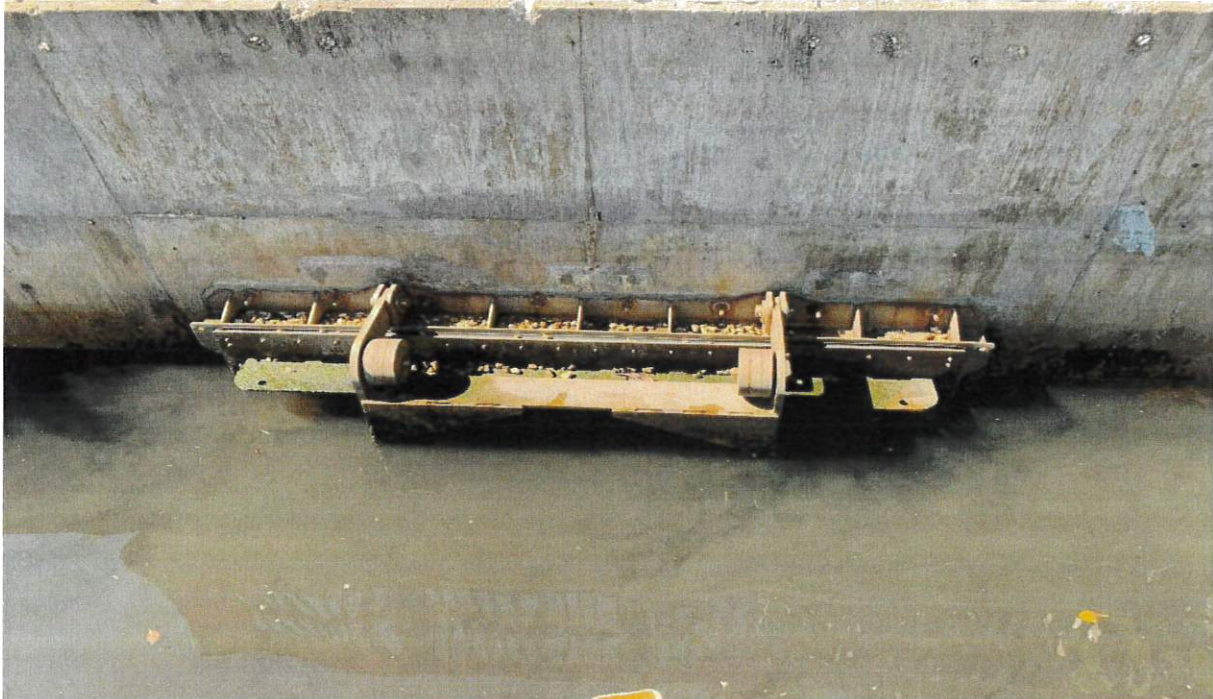
Water control structure #4

Comments:	
<ul style="list-style-type: none"> Upon arrival at gate #4 UESI noted very light growth on the exterior of the gate. The estimated length of soft growth was ¼" and a total coverage of 30%. The estimated height of the hard growth was ¼" with a coverage of 5% 	
<ul style="list-style-type: none"> The diver reported a sand and shell natural bottom of approximately 6" in depth on top of a fabric formed concrete mat. The bottom material was approximately 2-4" below the bottom of the gate. 	
<ul style="list-style-type: none"> The overall condition of the hardware was exceptional. Very light to moderate corrosion noted. All hardware/cotter pins were present and tight. 	
<ul style="list-style-type: none"> The overall condition of the gate and gate frame were exceptional. Very light corrosion noted with an estimated total coverage of 30%. 	
<ul style="list-style-type: none"> The condition of the gate seal was exceptional. Showed no indication of dry rot, splits or tearing.

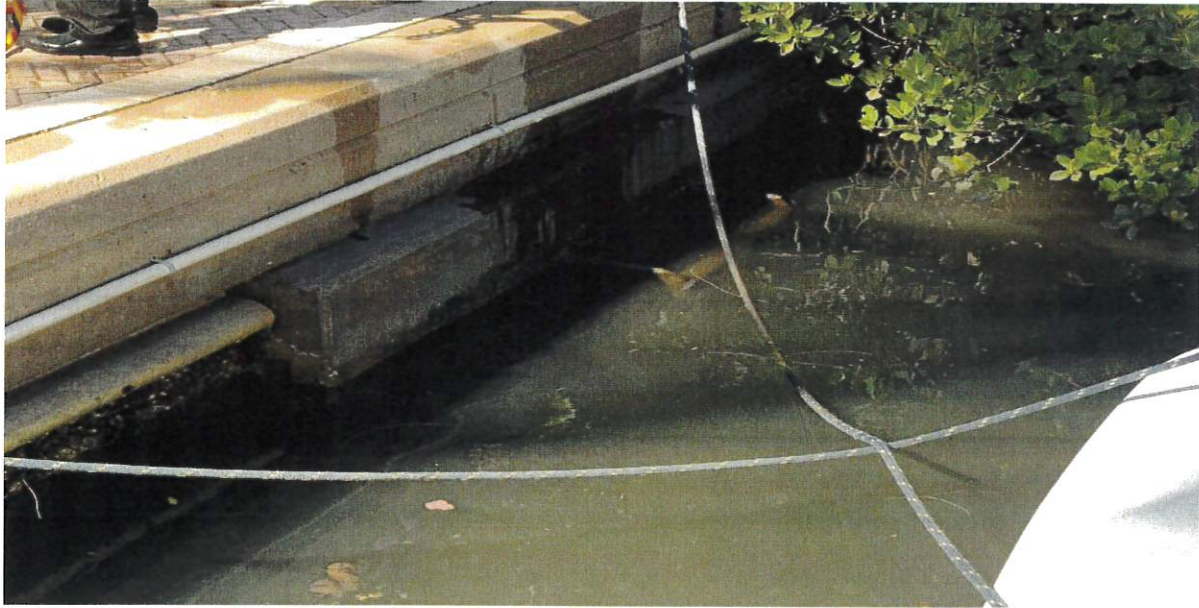
Water control structure #5

Comments:	
<ul style="list-style-type: none">• Upon arrival at gate #5 UESI noted very little hard growth on the exterior and interior of the gate. The estimated length of soft growth was ¼" and a total coverage of 30%.	
<ul style="list-style-type: none">• The diver reported a mud/sand and shell mix for natural bottom on the gate exterior side 2" to 4" below the gate invert.	
<ul style="list-style-type: none">• The overall condition of the concrete headwall appeared to be good. Some minor pop outs were noted. The average pop out dimensions were 1/4" diameter x 1/8" deep. The total coverage of the pop out was an estimated 5%. There was no indication of cracking or spalling noted.	
<ul style="list-style-type: none">• The overall condition of the Hardware was exceptional. Very light to moderate corrosion noted. All hardware/cotter pins were present and tight.	
<ul style="list-style-type: none">• The overall condition of the gate and gate frame were exceptional. Very light corrosion noted with an estimated total coverage of 40%.

<ul style="list-style-type: none">• The condition of the gate seal was exceptional. Showed no indication of dry rot, splits or tearing.

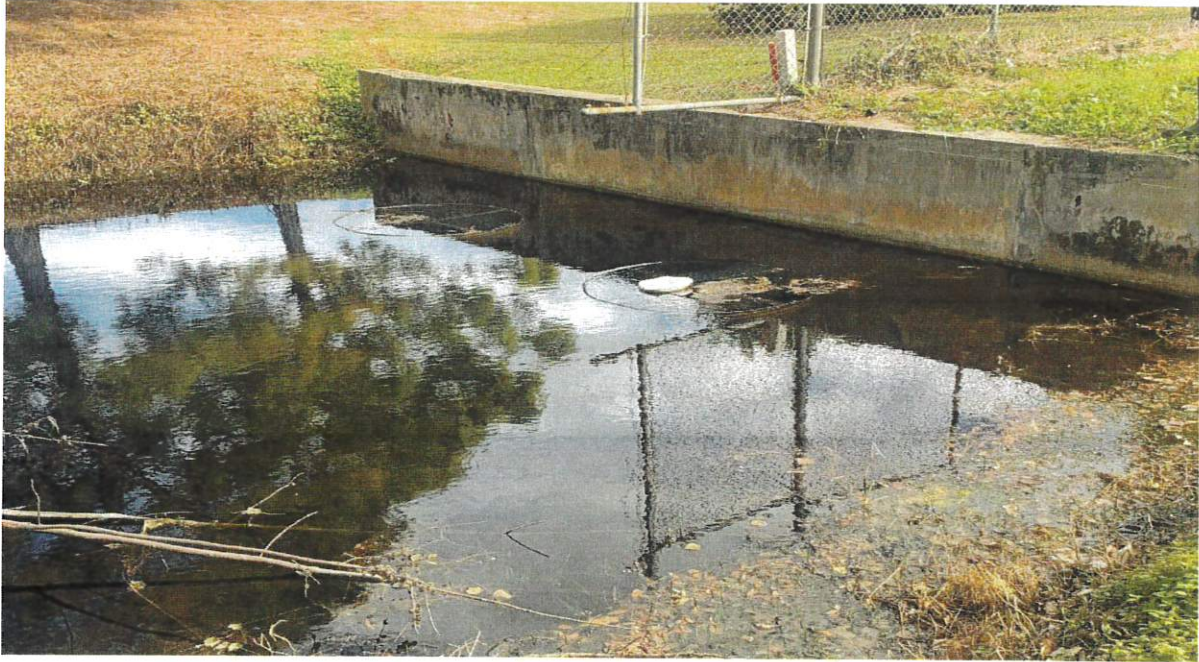
Picture above is the upstream side of water control structure #6

Comments:
<ul style="list-style-type: none">• Upon arrival at water control structure #6 UESI noted very little growth on the upstream exterior and interior of the corrugated riser and head wall. The downstream side was typical to the upstream side with little to no growth.
<ul style="list-style-type: none">• The diver reported large amount of organic debris consisting of leaf's sticks palm fronds on the upstream side with a depth of 3' plus with approximately 12" of freeboard to top of both the northern and southern culvert riser. Natural bottom on the downstream side was estimated to be even with the invert of both the northern and southern concrete culverts.
<ul style="list-style-type: none">• The overall condition of the concrete headwall appeared to be in good condition. A minor spall approx. 1 1/4 " deep x 9" square was noted at the 12 O'Clock position of the downstream South pipe. Some minor pop outs were noted. The average pop out dimensions were 1/4" diameter x 1/8" deep. The total coverage of the pop out was an estimated 5%. There was no indication of cracking or spalling noted.

<ul style="list-style-type: none">• The overall condition of upstream risers appeared to be in great shape. Very light corrosion noted. located on the upstream side was a flange that attached the culvert riser to the head wall. On the Sothern most riser flange the diver noted one nut at the 12 O'clock position that was backed out and galled approx. 1/2" from the headwall. The lower half of both risers had been covered with organic debris and the diver was unable it inspect due to accessibility.
