Underwater Engineering Services, Inc.

Jonathan's Landing Annual Inspection Report

Prepared for:
Lucas Jones
UESI Job No. COM2200054.00

On December 12-13 of 2022 UESI performed an annual underwater Inspection of the (WCS) Water Control Structure located within Jonathan's Landing. This inspection included: (1) Water Blasting the interior/exterior gate, frame and 6" of head wall around gate frame. (2) Assessing the condition of the exterior/interior concrete head wall, gate frame hardware and gate seals (3) Clean and lubricate gate seals and moving parts. (4) Determine the percentage of hard and soft growth (5) Identify any sediment/debris located within culverts as well as outside the WCS. This process was performed at (WCS) 1,2,3,4,5 and 6.

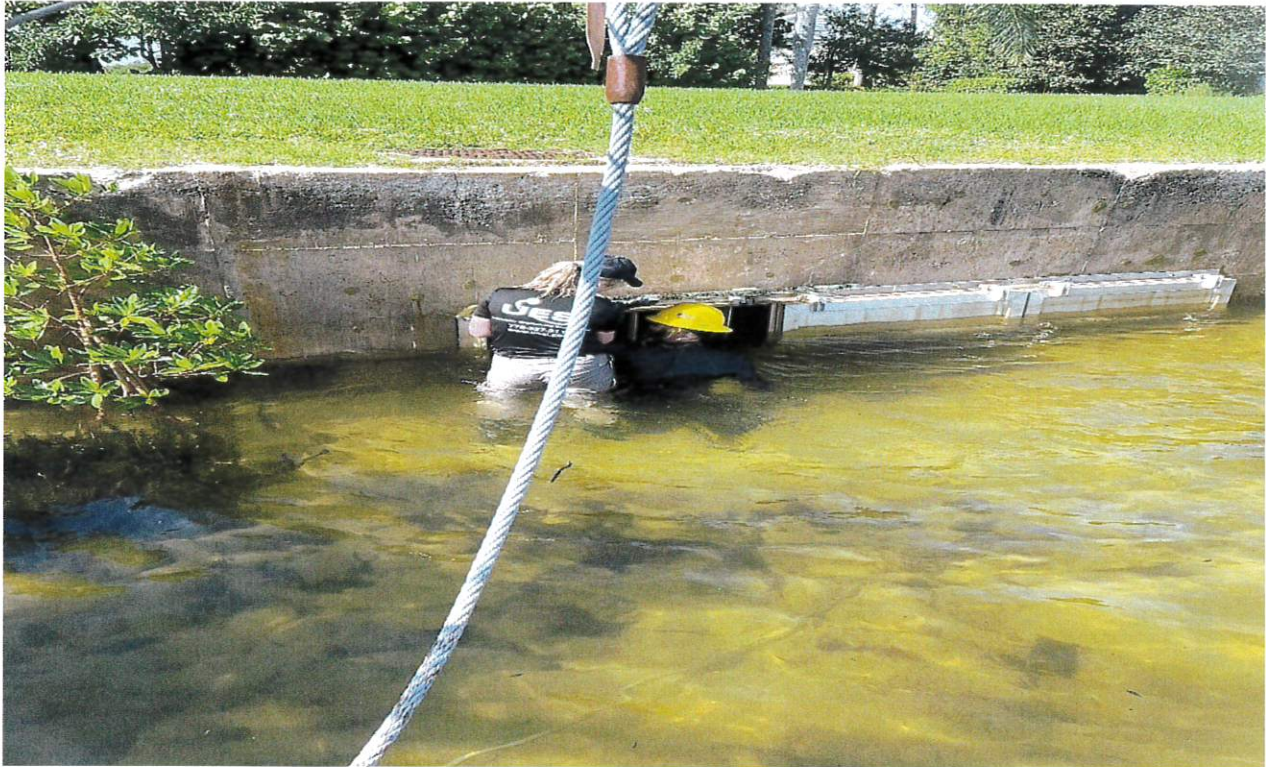
WATER CONTROL STRUCTURE #1

- **Hard Growth on the Exterior side** of the WCS had a total of **0 %** coverage of Hard Growth at an estimated height of **0 "** **Soft Growth on the Exterior side** was an estimated total coverage of **5 %** and a height of **1/16 "**.

- **Hard Growth on the Interior side** of the WCS had a total of **0 %** coverage of Hard Growth at an estimated height of **0 "** **Soft Growth on the Interior side** was an estimated total coverage of **100 %** and a height of **1/16" to 1/4"**.

- **Natural Bottom Report on the gate Exterior side:** was reported as a **SAND** bottom on the gate exterior side with **14** " of freeboard below the gates invert.
- **Natural Bottom Report on the gate Interior side:** was reported as a **SAND/ SHELL/ORGANIC** bottom on the gate Interior side with **46** " of freeboard below the gates invert.

Exterior Concrete Headwall appeared to be in **MODERATE** condition with **LIGHT** pop outs noted. The average pop out dimensions were **1/4** " in diameter and **1/8** " in depth? The total coverage of the pop out was an estimated at **100** %. There was **HEAVY** indication of cracking and loss in wall definition noted.

NOTES: 20 small 1" X 1" Splash zone repairs have been noted on the exterior headwall. Two of the splash zone repairs had rust staining or bleed through. Also noted was a hairline crack that started on the exterior headwall cap and ran vertical down through the southern side of the gate.

- **Interior Concrete Headwall** appeared to be in **POOR** condition with **HEAVY** loss in definition noted. The total coverage of the definition loss was an estimated at **60%**. There was **HEAVY** indication of cracking or spalling noted.

NOTES: The diver noted heavy definition loss on the interior wall of the culvert box. The definition loss was estimated to be 10% at an estimated 60% wall coverage below the waterline. The diver also noted a vertical diagonal hairline crack that ran from the bottom on the north side of the culvert box approximately 36" were it terminated. The diver was unable to detect any water flowing through the cracks.

- **The Gate and Gate frame Condition** was **MODERATE** with **LIGHT** corrosion noted with an estimated total coverage of **10%**.

- **Hardware on the Gate and Gate Frame** showed signs of **LIGHT** corrosion. All hardware/cotter pins were present **NO** and tight **YES**
Bolt Count **26 total / MISSING 11 STUDS** in gate frame to headwall

- **Gates seals** showed **HEAVY** indication of dry rot, splits or tearing. Overall condition of gate seals appeared to be in **POOR**. Needs replaced **YES**

1. WCS #1 was in poor condition. There weren't any rubber gate seals on all three gate flappers. Also noted when crew first arrived the gates flappers were opening and closing due to the boat traffic wake on the intercoastal allowing saltwater back feed the system. The diver also noted heavy definition loss to the concrete wall within the interior culvert box. Uesi recommends Jonathan's Landing consider replacing the head wall as well as the WCS.

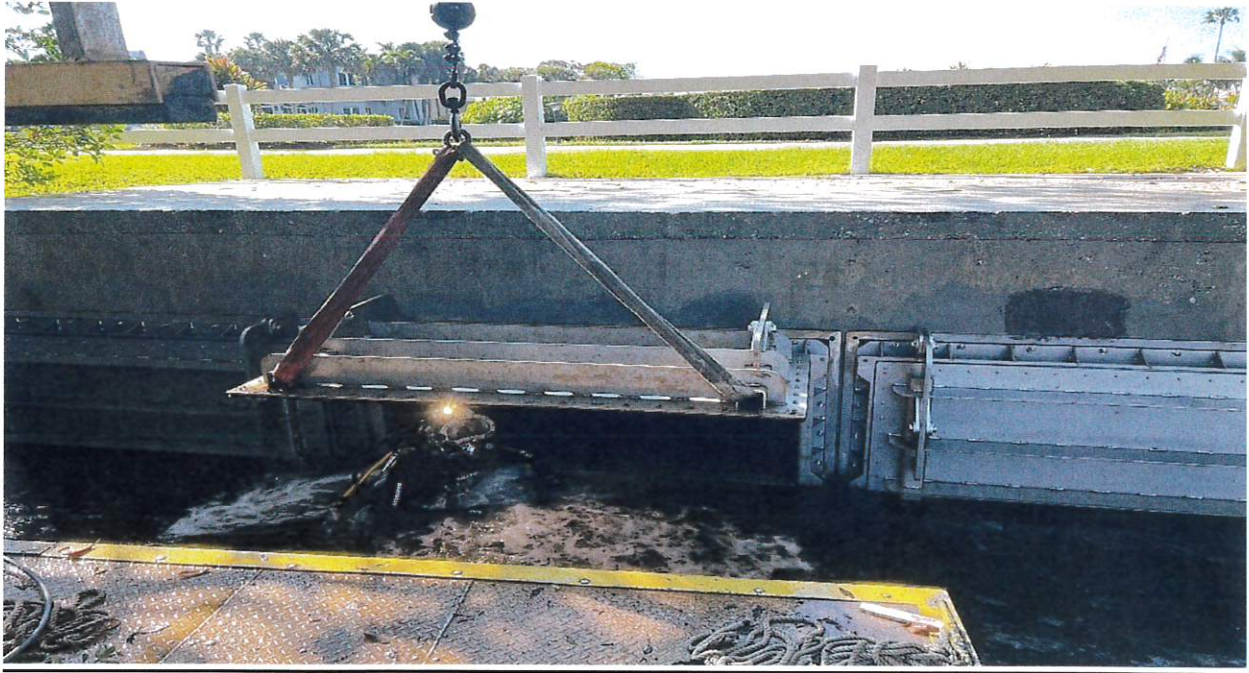
WATER CONTROL STRUCTURE #2

- ***Hard Growth on the Exterior side*** of the WCS had a total of **40 %** coverage of Hard Growth at an estimated height of **1/2"** **Soft Growth on the Exterior side** was an estimated total coverage of **10 %** and a height of **1/2 "**.

- ***Hard Growth on the Interior side*** of the WCS had a total of **0 %** coverage of Hard Growth at an estimated height of **0 "** **Soft Growth on the Interior side** was an estimated total coverage of **50 %** and a height of **5"**.

- ***Natural Bottom Report on the gate Exterior side:*** was reported as a **SAND/MUD/ORGANIC** bottom on the gate exterior side with **53 "** of freeboard below the gates invert.
- ***Natural Bottom Report on the gate Interior side:*** was reported as a **SAND/ SHELL/ORGANIC** bottom on the gate Interior side with **68 "** of freeboard below the gates invert.

- **Exterior Concrete Headwall** appeared to be in **MODERATE** condition with **LIGHT** pop outs noted. The average pop out dimensions were **1/4"** in diameter and **1/8"** in depth? The total coverage of the pop out was an estimated at **100** %. There was **HEAVY** indication of cracking and loss in wall definition noted.

- **Interior Concrete Headwall** appeared to be in **MODERATE** condition with **LIGHT** pop outs noted. The average pop out dimensions were **1/4"** in diameter and **1/8"** in depth? The total coverage of the pop out was an estimated at **3%**. There was **NO** indication of cracking or spalling noted.

- **The Gate and Gate frame Condition** was in **EXCELLENT** condition with **LIGHT** corrosion noted with an estimated total coverage of **5%**.

- **Hardware on the Gate and Gate Frame** showed signs of **LIGHT** corrosion. All hardware/cotter pins were present **YES** and tight **YES**
Bolt Count **26 total / MISSING 11 STUDS** in gate frame to headwall

- **Gates seals** showed **MODERIT** indication of dry rot, splits or tearing. Overall condition of gate seals appeared to be in **POOR**. Needs replaced **YES**

NOTES: All three gate seals at structure #2 the bottom corner are splitting and need replacing.

2. WCS #2 overall was in excellent condition the only thing noted was that the flapper gate seals need to be replaced.
3. WCS #3 gate and headwall was in excellent condition. UESI recommends Jonathan's Landing consider adding a pump mat to prevent embankment erosion.

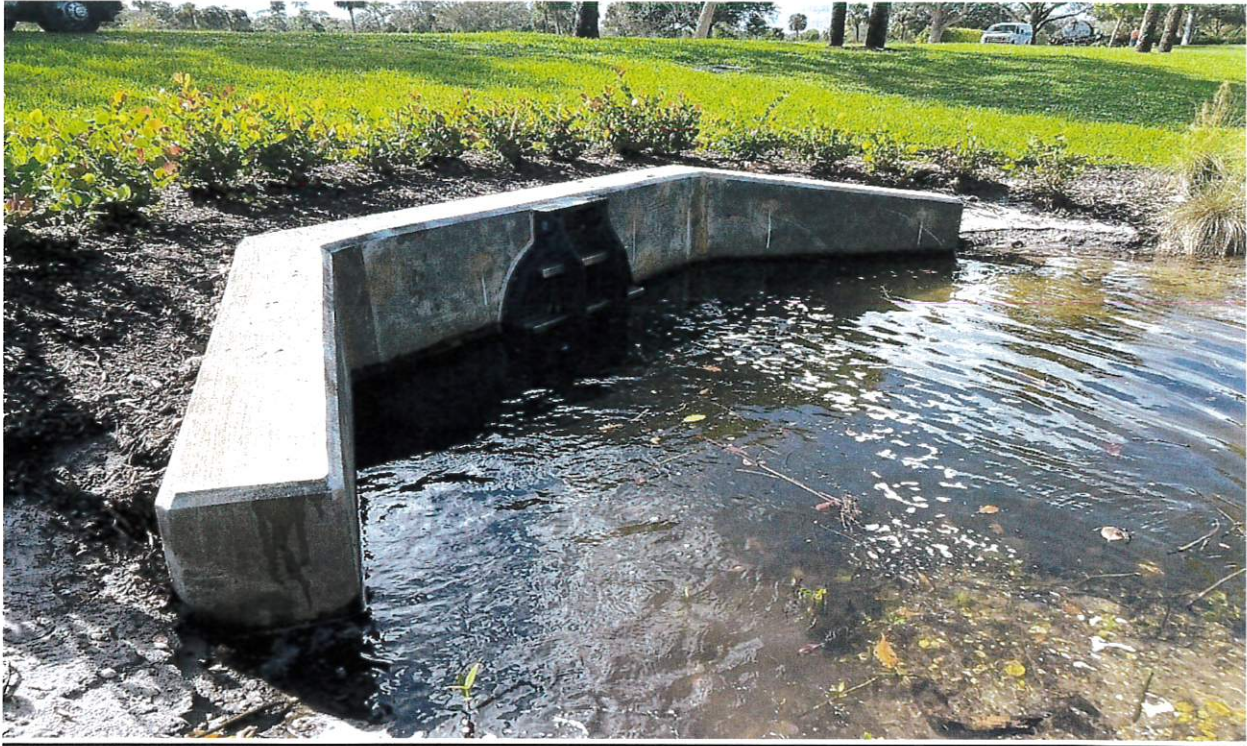
WATER CONTROL STRUCTURE #3

- ***Hard Growth on the Exterior side*** of the WCS had a total of **0 %** coverage of Hard Growth at an estimated height of **0 "** ***Soft Growth on the Exterior side*** was an estimated total coverage of **25 %** and a height of **1/16 "**.

- ***Hard Growth on the Interior side*** of the WCS had a total of **0 %** coverage of Hard Growth at an estimated height of **0 "** ***Soft Growth on the Interior side*** was an estimated total coverage of **25 %** and a height of **1/16 "**.

- ***Natural Bottom Report on the gate Exterior side:*** was reported as a **SAND/SHELL** bottom on the gate exterior side with **5 ½ "** of freeboard below the gates invert. UESI recommends adding pump mats to prevent bank erosion
- ***Natural Bottom Report on the gate Interior side:*** was reported as a **N/A** bottom on the gate Interior side with **N/A "** of freeboard below the gates invert.

- **Exterior Concrete Headwall** appeared to be in **EXCELLENT** condition with **NO** pop outs noted. The average pop out dimensions were **N/A** " in diameter and **N/A** " in depth? The total coverage of the pop out was an estimated at **0** %. There was **NO** indication of cracking and loss in wall definition noted.

- **Interior Concrete Headwall** appeared to be in **EXCELLENT** condition with **NO** pop outs noted. The average pop out dimensions were **N/A** " in diameter and **N/A** " in depth? The total coverage of the pop out was an estimated at **0** %? There was **NO** indication of cracking or spalling noted.

- **The Gate and Gate frame Condition** was **MODERATE** with **LIGHT** corrosion noted with an estimated total coverage of **10**%.

- **Hardware on the Gate and Gate Frame** showed signs of **LIGHT** corrosion. All hardware/cotter pins were present **NO** and tight **YES**
Bolt Count **26 total / MISSING 11 STUDS** in gate frame to headwall

- **Gates seals** showed **NO** indication of dry rot, splits or tearing. Overall condition of gate seals appeared to be in **EXCELLENT**. Needs replaced **NO**

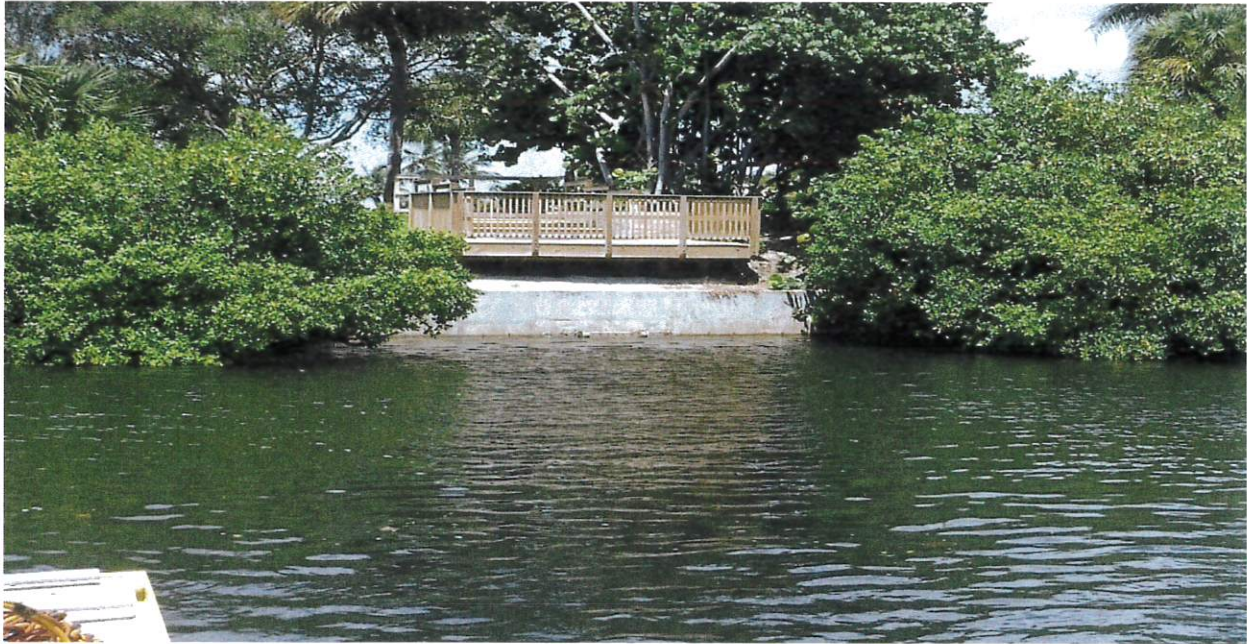
WATER CONTROL STRUCTURE #4

- **Hard Growth on the Exterior side** of the WCS had a total of **70 %** coverage of Hard Growth at an estimated height of **1/2"** **Soft Growth on the Exterior side** was an estimated total coverage of **30 %** and a height of **1"**.

- **Hard Growth on the Interior side** of the WCS had a total of **70 %** coverage of Hard Growth at an estimated height of **1/2"** **Soft Growth on the Interior side** was an estimated total coverage of **30 %** and a height of **1"**.

- **Natural Bottom Report on the gate Exterior side:** was reported as a **SAND/MUD/** bottom on the gate exterior side with **3"** of freeboard below the gates invert.
- **Natural Bottom Report on the gate Interior side:** was reported as a **NO SEDIMENT** was noted b on the gate Interior side with **0"** of freeboard below the gates invert.

- ***Exterior Concrete Headwall*** appeared to be in **MODERATE** condition with **MODERATE** pop outs noted. The average pop out dimensions were **1/4** " in diameter and **1/8** " in depth? The total coverage of the pop out was an estimated at **5** %. There was **NO** indication of cracking and loss in wall definition noted.

- ***Interior Concrete Headwall*** appeared to be in **MODERATE** condition with **LIGHT** pop outs noted. The average pop out dimensions were **1/4** " in diameter and **1/8** " in depth? The total coverage of the pop out was an estimated at **3** %? There was **NO** indication of cracking or spalling noted.

- ***The Gate and Gate frame Condition*** was in **EXCEPTIONAL** condition with **LIGHT** corrosion noted with an estimated total coverage of **40%**.

- ***Hardware on the Gate and Gate Frame*** showed signs of **LIGHT** corrosion. All hardware/cotter pins were present **YES** and tight **YES**
Bolt Count **32 total**

- ***Gates seals*** showed **MODERATE** indication of dry rot, splits or tearing. Overall condition of gate seals appeared to be in **POOR**. Needs replaced **YES**

NOTES: Gate seals at structure #4 the bottom corner are splitting and need replacing.

4. WCS #4 gate and headwall was in excellent condition. UESI recommends Jonathan's Landing consider replacing flapper gate seals due to splitting and tearing on the existing gate seal.

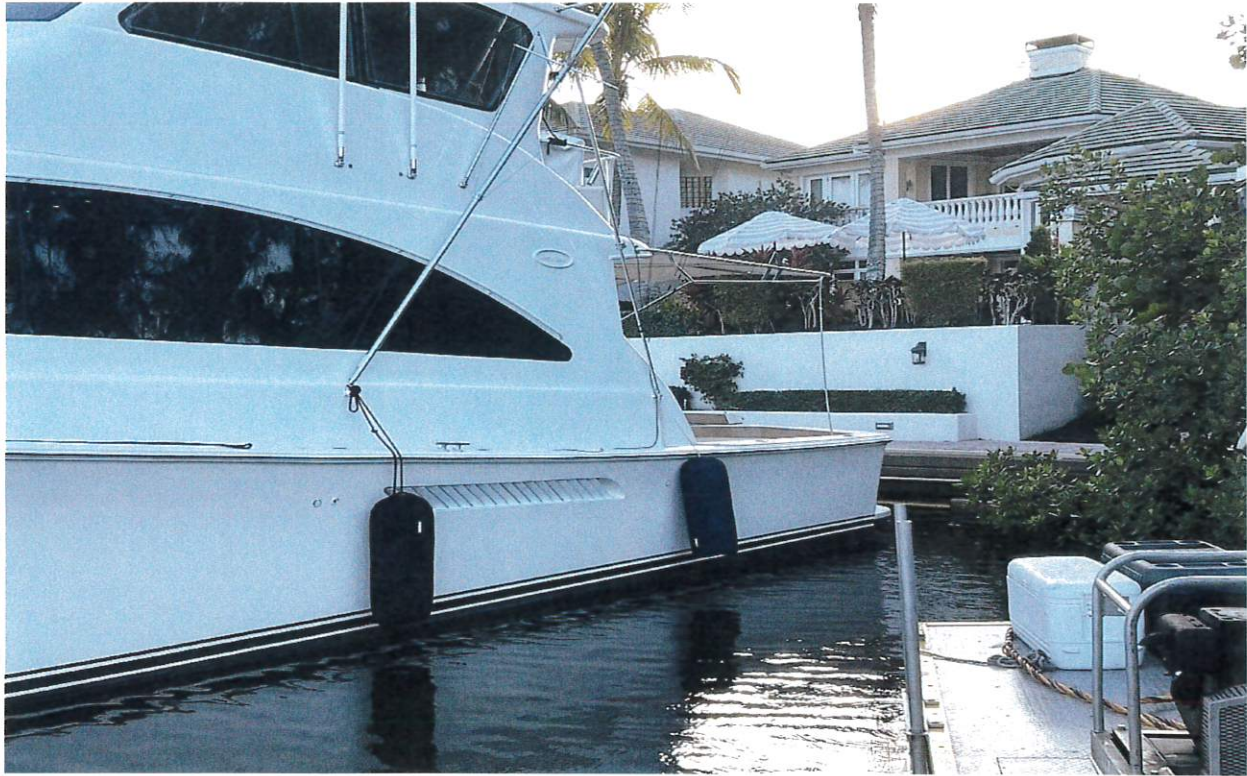
WATER CONTROL STRUCTURE #5

- ***Hard Growth on the Exterior side*** of the WCS had a total of **70 %** coverage of Hard Growth at an estimated height of **1/2"** **Soft Growth on the Exterior side** was an estimated total coverage of **30 %** and a height of **1"**.

- ***Hard Growth on the Interior side*** of the WCS had a total of **70 %** coverage of Hard Growth at an estimated height of **1/2"** **Soft Growth on the Interior side** was an estimated total coverage of **30 %** and a height of **1"**.

- ***Natural Bottom Report on the gate Exterior side:*** was reported as a **SAND/MUD/** bottom on the gate exterior side with **3"** of freeboard below the gates invert.
- ***Natural Bottom Report on the gate Interior side:*** was reported as a **NO SEDIMENT** was noted b on the gate Interior side with **0"** of freeboard below the gates invert.

- **Exterior Concrete Headwall** appeared to be in **MODERATE** condition with **MODERATE** pop outs noted. The average pop out dimensions were **1/4 "** in diameter and **1/8 "** in depth? The total coverage of the pop out was an estimated at **5 %**. There was **NO** indication of cracking and loss in wall definition noted.

- **Interior Concrete Headwall** appeared to be in **MODERATE** condition with **LIGHT** pop outs noted. The average pop out dimensions were **1/4 "** in diameter and **1/8 "** in depth? The total coverage of the pop out was an estimated at **3 %**? There was **NO** indication of cracking or spalling noted.

- **The Gate and Gate frame Condition** was in **EXCEPTIONAL** condition with **LIGHT** corrosion noted with an estimated total coverage of **40%**.

- **Hardware on the Gate and Gate Frame** showed signs of **LIGHT** corrosion. All hardware/cotter pins were present **YES** and tight **YES**
Bolt Count **32 total**

- **Gates seals** showed **MODERATE** indication of dry rot, splits or tearing. Overall condition of gate seals appeared to be in **POOR**. Needs replaced **YES**

NOTES: Gate seals at structure #5 the bottom and top corners are splitting and need replacing.

The divers couldn't complete the interior gate inspection due to a vessel being moored on the gates exterior side. See photo above

5. WCS #5 gate and headwall was in excellent condition. UESI recommends Jonathan's Landing consider replacing flapper gate seals due to splitting and tearing on the existing gate seal.

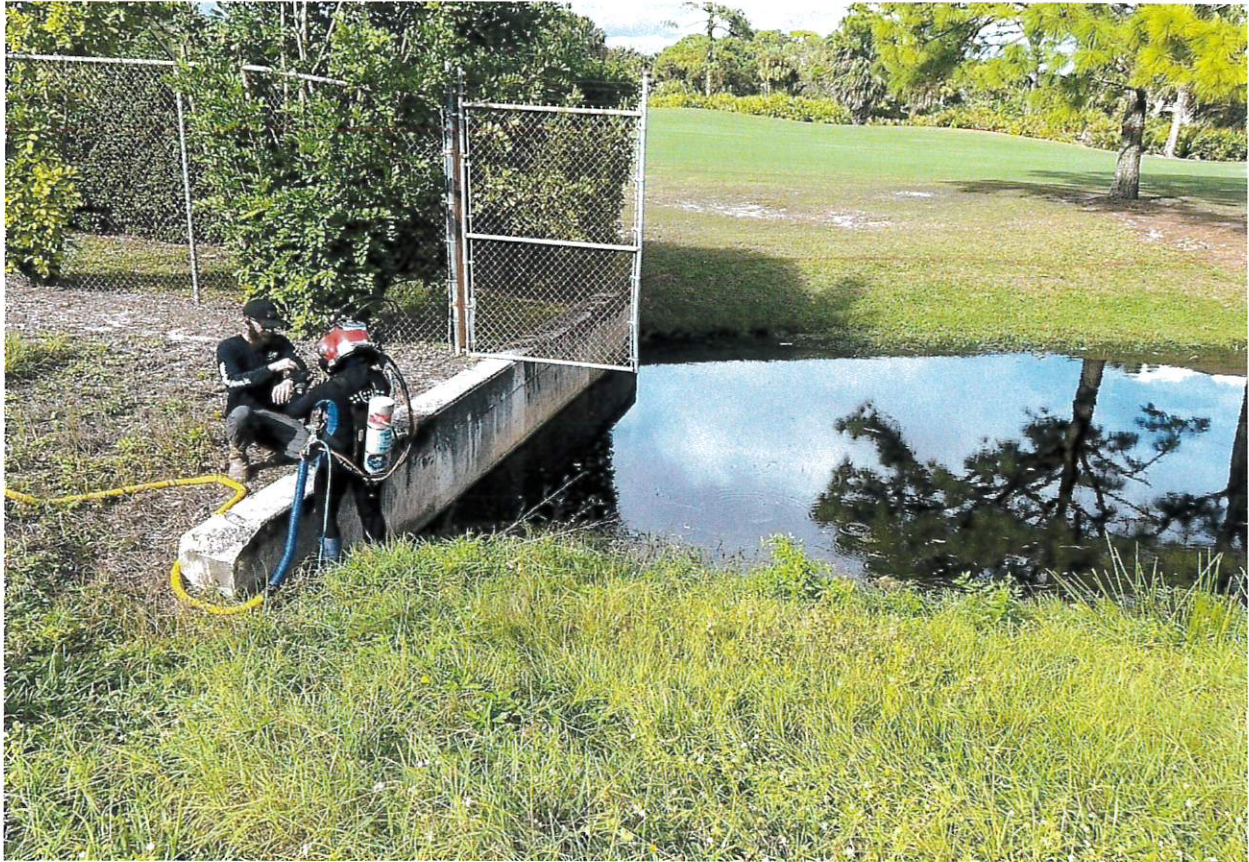
WATER CONTROL STRUCTURE #6

- **Upstream Exterior Concrete Headwall** appeared to be in **MODERATE** condition with **MODERATE** pop outs noted. The average pop out dimensions were **1/4** " in diameter and **1/8** " in depth? The total coverage of the pop out was an estimated at **5** %. There was **NO** indication of cracking and loss in wall definition noted.

- **Downstream Exterior Concrete Headwall** appeared to be in **MODERIT** condition with **MODERIT** pop outs noted. The average pop out dimensions were **1/4** " in diameter and **1/8** " in depth? The total coverage of the pop out was an estimated at **5** %. There was **NO** indication of cracking and loss in wall definition noted.

- **Natural Bottom Report on the upstream side of both the Northern and Southern culvert risers** was reported as an **ORGANIC/MUD** bottom on the upstream side with **31** " of freeboard below the culvert riser opening to top of sediment.

- **Natural Bottom Report on the downstream side of both Northern and Southern culverts:** was reported as an ORGANIC/SAND/MUD bottom on the downstream side with 3" of freeboard below the culverts invert.
- **Sediment reported within both culverts** the diver reported very little to no sediment within the two culverts. An estimated 1" of sediment was found within the first seven foot west of the pipes opening.

6. WCS #6 headwall and culverts are in excellent condition. No attention needed.
