Jonathan's Landing

Annual Inspection Report

Prepared for:
Lucas Jones
UESI Job No. COM2400039.00

Date: 11/20/2024

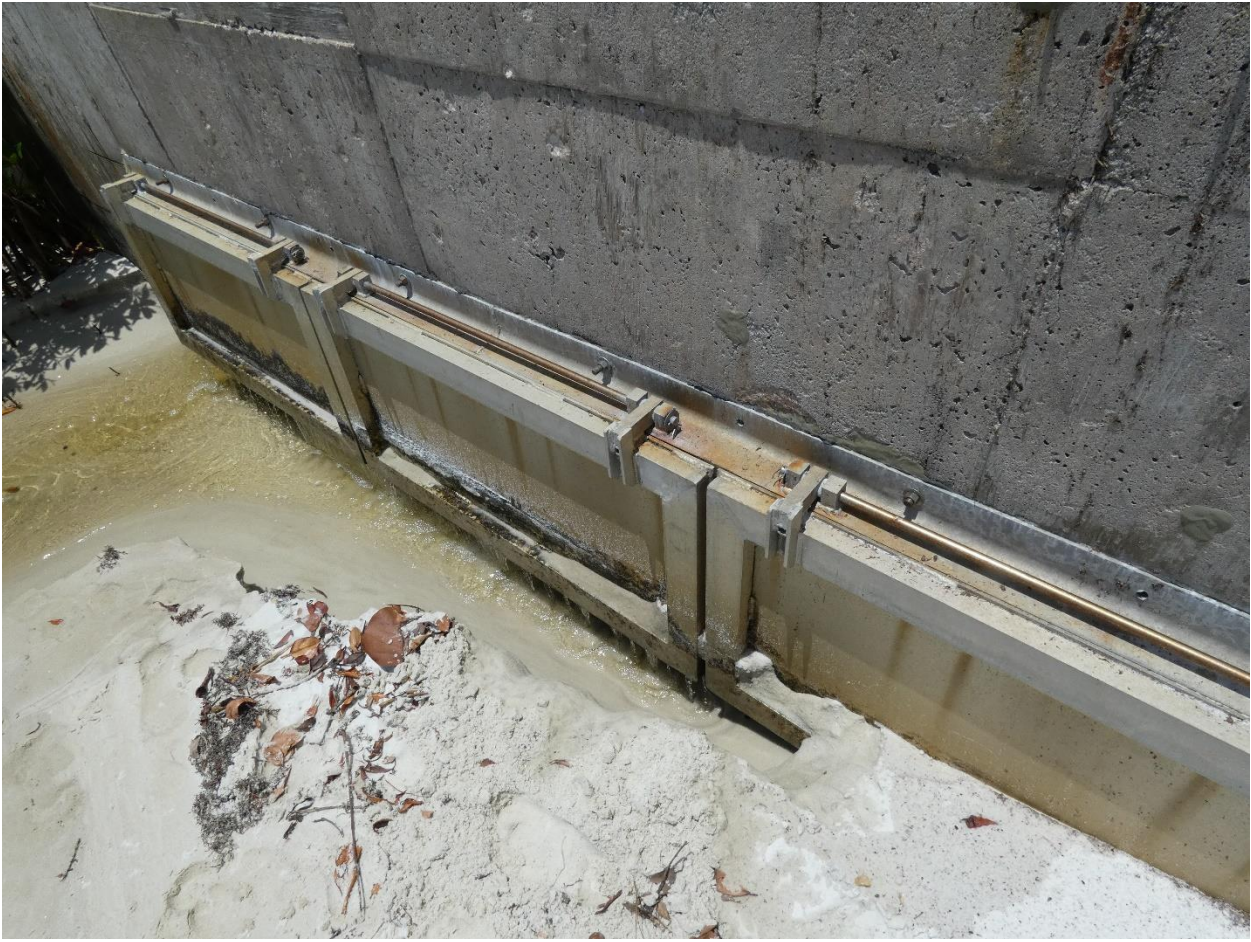
WATER CONTROL STRUCTURE #1

- **Hard Growth on the Exterior side** of the WCS had a total of 0% coverage of Hard Growth at an estimated height of **N/A**. Soft Growth on the Exterior side was an estimated total coverage of 5%

- **Natural Bottom Report on the gate Exterior side:** was reported as sand at bottom on the gate exterior side with 8" of freeboard below the gates invert on the north side and 8" on the Southernmost.

- **Exterior Concrete Headwall** appeared to be in moderate condition with light pop outs noted. The average pop out dimensions were 1/4" in diameter and 1/8" in depth. The total coverage of the pop out was an estimated at 100% There is heavy indication of cracking or spalling noted. All Cracks are currently being repaired at the time of inspection.
- **The Gate and Gate frame Condition** was excellent with light surface corrosion noted with an estimated total coverage of 5%.

NOTES: Small amount of surface corrosion. No Pitting.

- **Hardware on the Gate and Gate Frame** showed signs of LIGHT SURFACE corrosion noted. All hardware/cotter pins were present and tight.
Bolt Count_16 total concrete anchors were exposed.
COTTER PINS_6 total cotter pins

NOTES: Northernmost cotter pin is damaged and needs replacing. Gates have no seals and according to the homeowner the gates slam open and closed with the wake from passing boats.

1. WCS #1 Already noted in previous inspection reports, all three gates had no seals. However, the concrete headwall is currently being repaired by another company. While it appears that the repairs are going well, the condition of the wall after the repairs cannot be determined at this time. Bottom sediment is not blocking the gates as previously noted in past inspections.

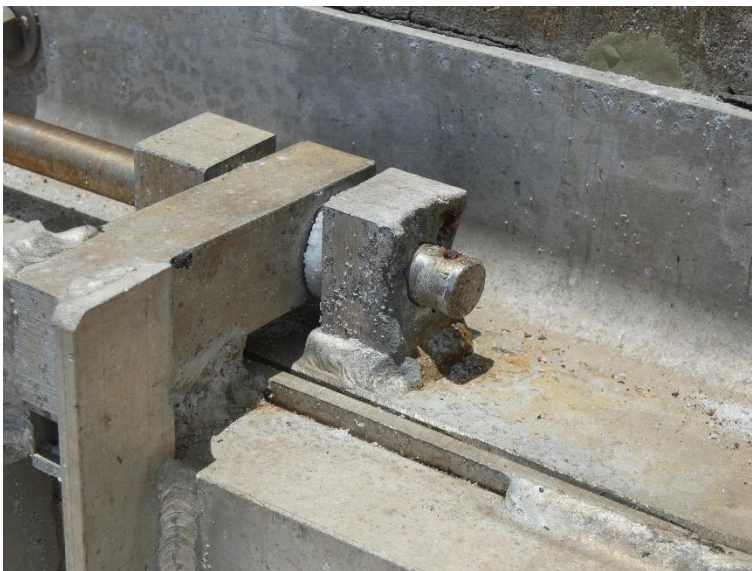
Photo of northern cotter pin which has corroded away.

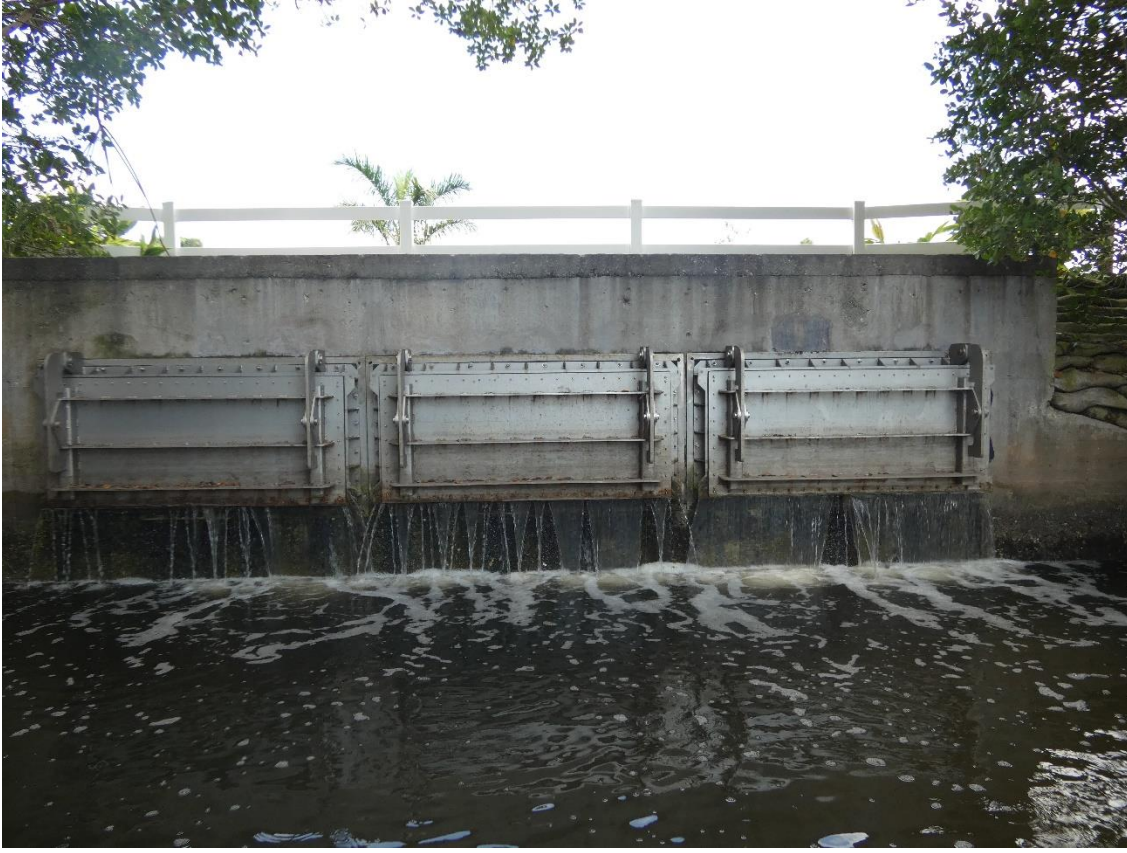
WATER CONTROL STRUCTURE #2

- **Hard Growth on the Exterior side** of the WCS had a total of 0% coverage of Hard Growth at an estimated height of N/A” Soft Growth on the Exterior side was an estimated total coverage of 10% and a height of 1/8”.

- **Natural Bottom Report on the gate Exterior side:** was reported as Rock bottom on the gate exterior side with 40” of freeboard below the gates invert.
- **Exterior Concrete Headwall** appeared to be in Excellent condition with Light pop outs noted. The average pop out dimensions were 1/4” in diameter and 1/8” in depth? The total coverage of the pop out was an estimated at 10% There was no indication of cracking or spalling noted.

NOTES: Previous Head wall repairs appear to be in excellent condition

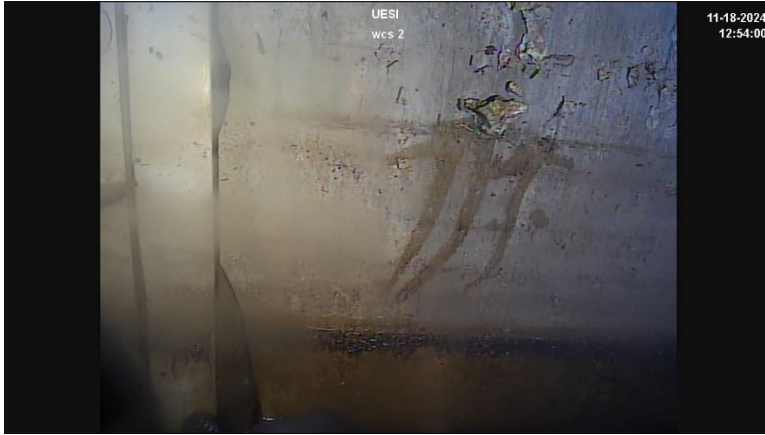
- **The Gate and Gate frame Condition** was Excellent with Light Surface corrosion noted with an estimated total coverage of 10%.

NOTES: Minor surface corrosion. No Pitting

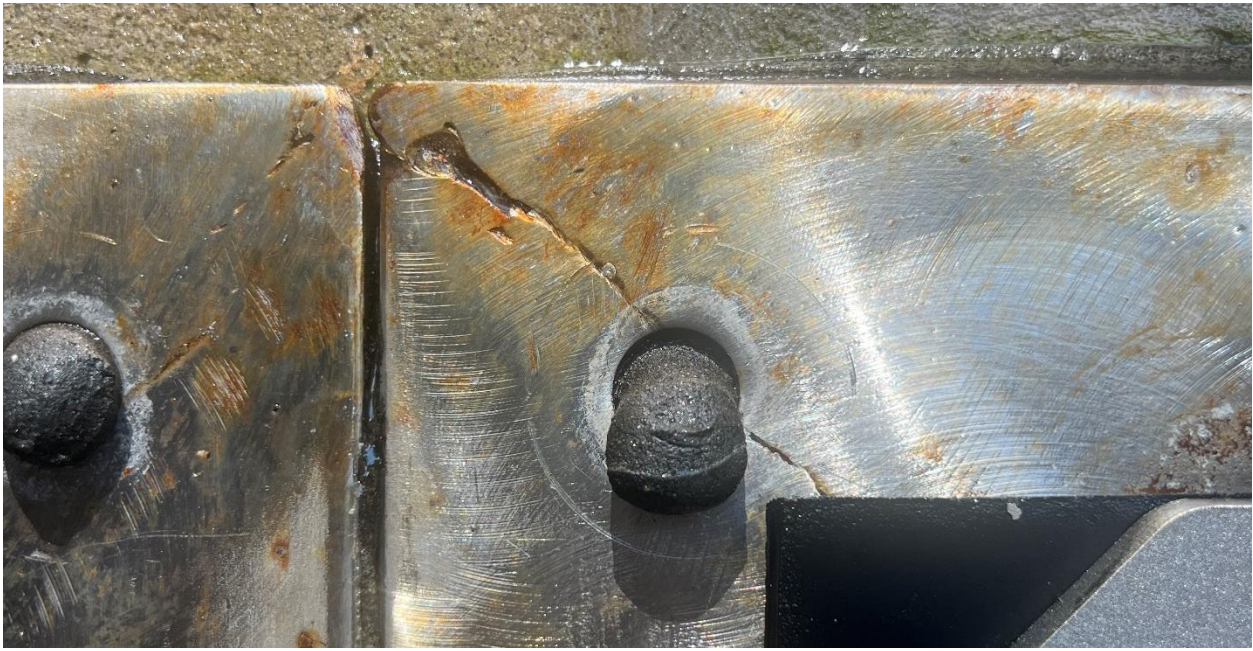
- **Hardware on the Gate and Gate Frame** showed signs of light surface corrosion noted. All hardware/cotter pins were present Yes and tight Yes
Bolt Count 72 total concrete anchors
COTTER PINS 24 total cotter pins

Notes: there are underfilled welds at the corners of the base plates, with the top southern side of the middle gate being the most pronounced. There is no structural concern.

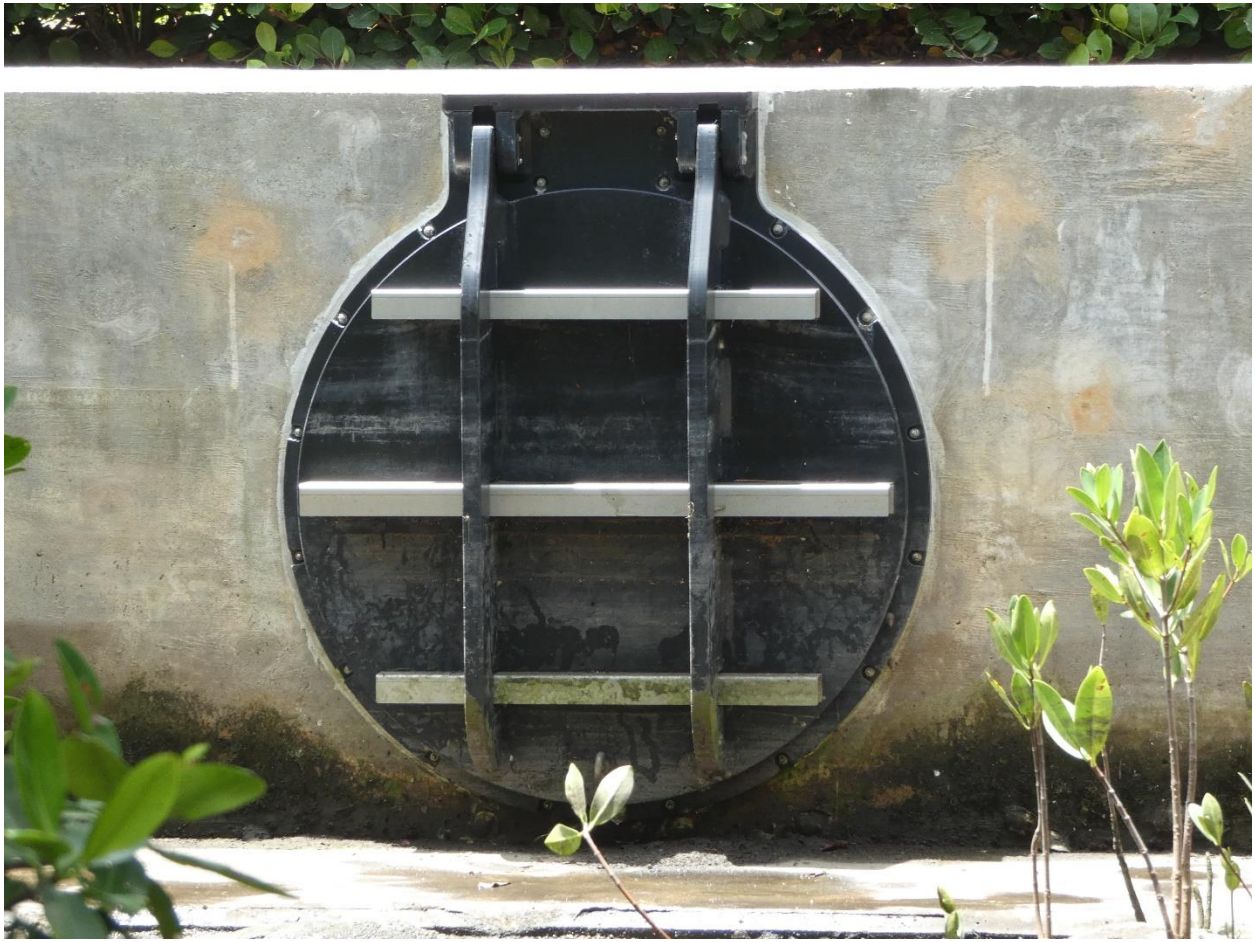
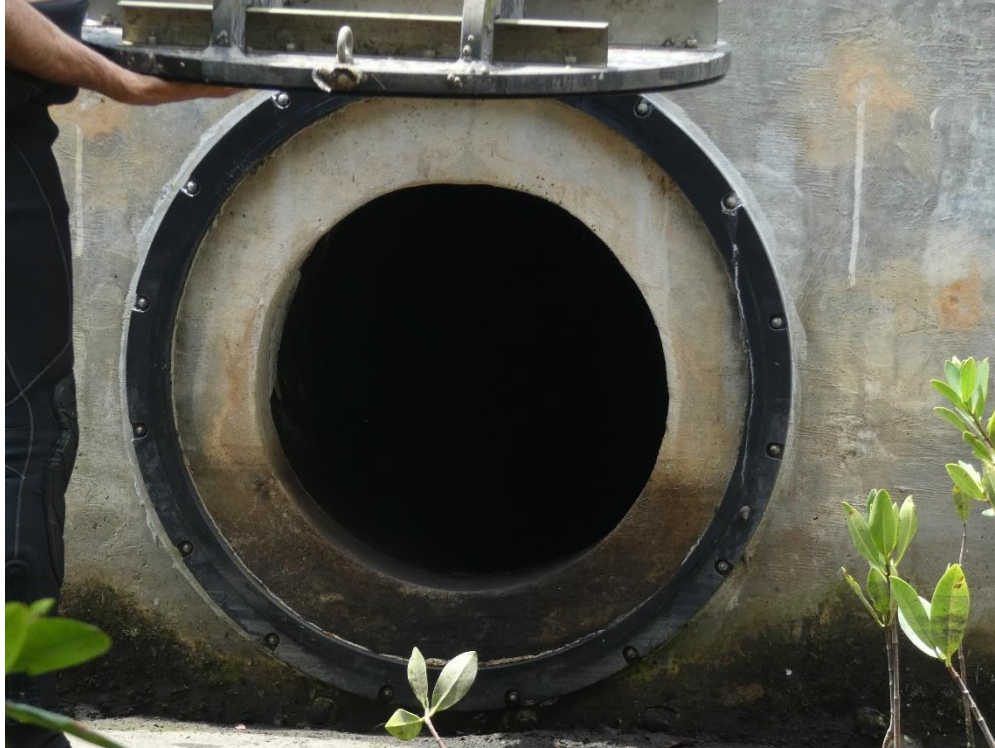
WATER CONTROL STRUCTURE #3

- **Hard Growth on the Exterior side** of the WCS had a total of 0% coverage of Hard Growth at an estimated height of 0" **Soft Growth on the Exterior side** was an estimated total coverage of 0% and a height of 0".

- **Natural Bottom Report on the gate Exterior side:** was reported as a Concrete slab with no material covering.
- **Exterior Concrete Headwall** appeared to be in EXCELLENT condition with NO pop outs noted. The average pop out dimensions were N/A" in diameter and N/A " in depth? The total coverage of the pop out was an estimated at 0%. There was No indication of cracking and loss in wall definition noted.

- **The Gate and Gate frame Condition** was moderate with no corrosion noted with an estimated total coverage of 5%.
- **Hardware on the Gate and Gate Frame** showed signs of light corrosion. All hardware/cotter pins were present yes and tight yes
16 bolts

- **Gates seals** showed no indication of dry rot, splits or tearing. Overall condition of gate seals appeared to be in excellent. Needs replaced no

NOTES: Everything was as expected from previous inspection.

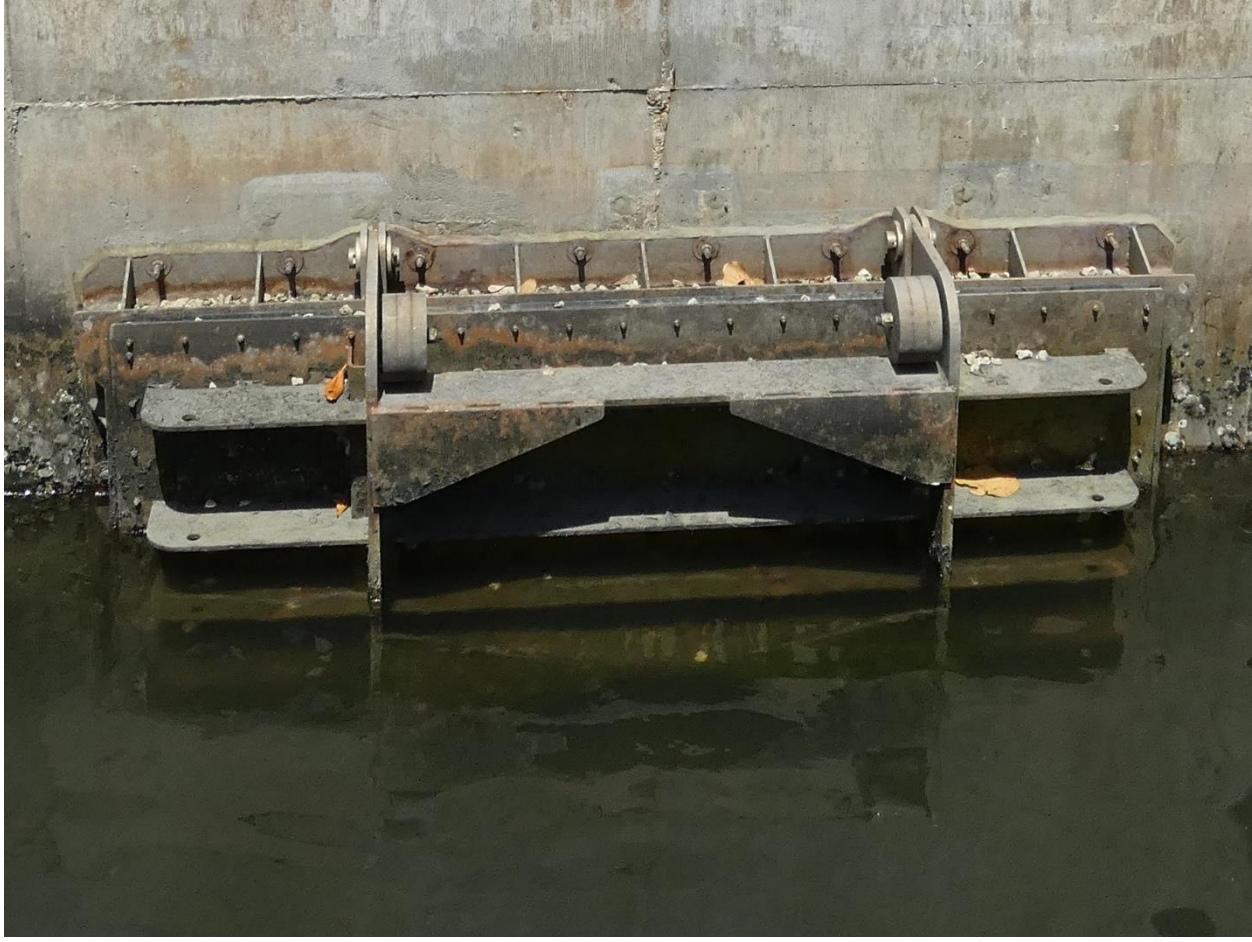
WATER CONTROL STRUCTURE #4

- **Hard Growth on the Exterior side** of the WCS had a total of 15% coverage of Hard Growth at an estimated height of 1/2" Soft Growth on the Exterior side was an estimated total coverage of 90% and a height of 1/2".
- **Natural Bottom Report on the gate Exterior side:** was reported as mud at bottom on the gate exterior side with 0" of freeboard below the gate. During the initial as found inspection there was soft silt covering the northern half of the gate with a depth above gate bottom of 6". The soft silt was removed by the diver to 1-2" below the bottom of the gate. UESI recommends dredging the area in front of the gate.

NOTES: Bottom sediment comes all the way up to the bottom of the swing gate. This is going to adversely affect the gates function in opening/closing. And creating a proper seal.

- **Exterior Concrete Headwall** appeared to be in moderate condition with light pop outs noted. The average pop out dimensions were 1/4" in diameter and 1/8" in depth. The total coverage of the pop out was an estimated at 5% There was no indication of cracking or spalling noted.
NOTES: Splash zone epoxy seal around gate frame appears to be in excellent condition.

4. WCS #4 gate and headwall was in excellent condition. Bottom sediment is going to drastically affect gates performance. UESI recommends dredging out material.

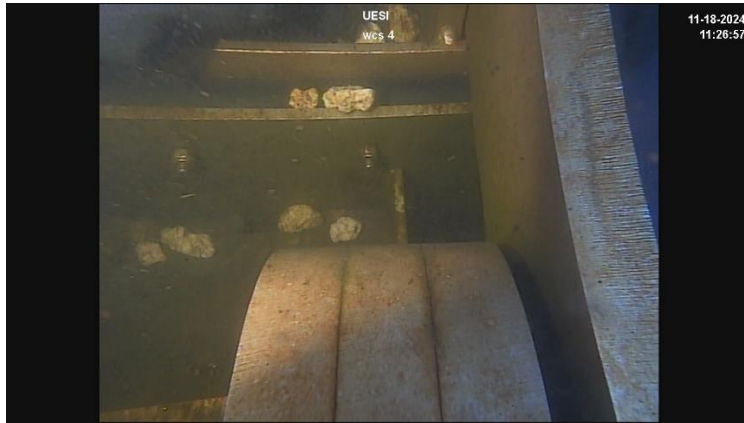
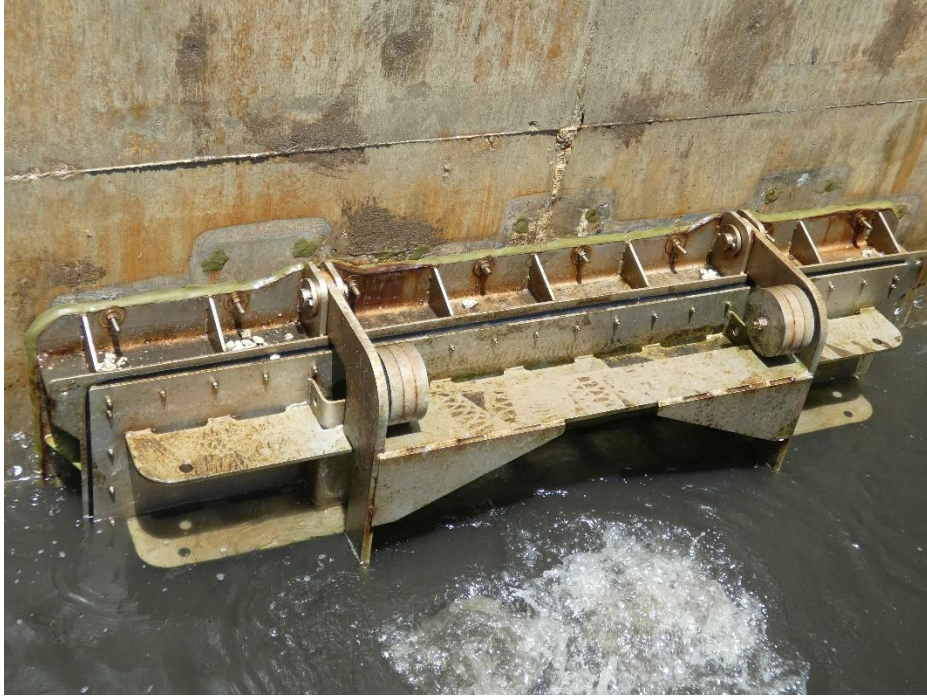
- **The Gate and Gate frame Condition** was excellent with light/moderate SURFACE corrosion noted with an estimated total coverage of 50%.

NOTES: Moderate surface corrosion. No Pitting

- **Hardware on the Gate and Gate Frame** showed signs of light surface corrosion noted. all hardware/cotter pins were present yes and tight yes
 Bolt count_32 total concrete anchors
 Cotter pins 8 total cotter pins

NOTES: Everything was as expected from previous inspection. UESI recommends dredging out material from bottom of gate to maximize gate performance.

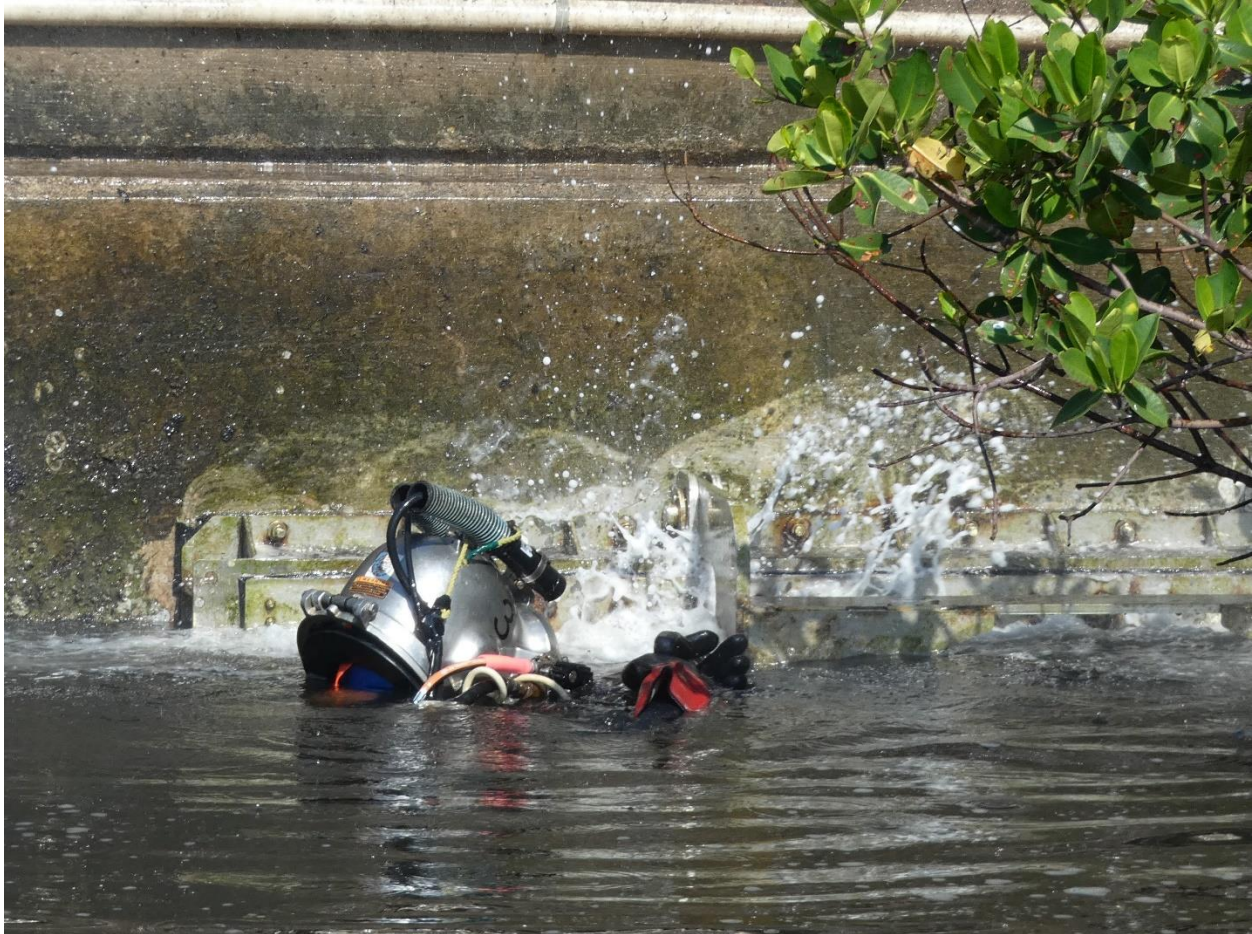
WATER CONTROL STRUCTURE #5

- **Hard Growth on the Exterior side** of the WCS had a total of 25% coverage of Hard Growth at an estimated height of 1/4" Soft Growth on the Exterior side was an estimated total coverage of 90% and a height of 1/4".
- **Natural Bottom Report on the gate Exterior side:** was reported as a rock/mud bottom on the gate exterior side with 48" of freeboard below the gates invert.
- **Exterior Concrete Headwall** appeared to be in excellent condition. There was no indication of cracking or spalling noted.
- **The Gate and Gate frame Condition** was excellent with light corrosion noted with an estimated total coverage of 10%.
NOTES: Moderate surface corrosion. No Pitting
- **Hardware on the Gate and Gate Frame** showed signs of light corrosion noted. All hardware/cotter pins were present yes and tight yes ?
Bolt Count 32

NOTES: while not part of the inspection, UESI examined issues that had been identified during the annual inspection of this structure in November 2023, namely a void that has opened on the north side of the culvert approximately 6ft east of the flap gate, and root intrusion into the 2nd storm grate east of the gate. Matt Herold showed Lucas Jones of Jonathan's Landing both of these issues.

5. WCS #5 gate and headwall was in excellent condition. UESI recommends performing a cleaning of the interior of the culvert to remove sedimentation and repair the joints where soil intrusion has occurred. UESI also recommends removing the split leaf philodendron from around the storm drains and remove the roots from the structure.

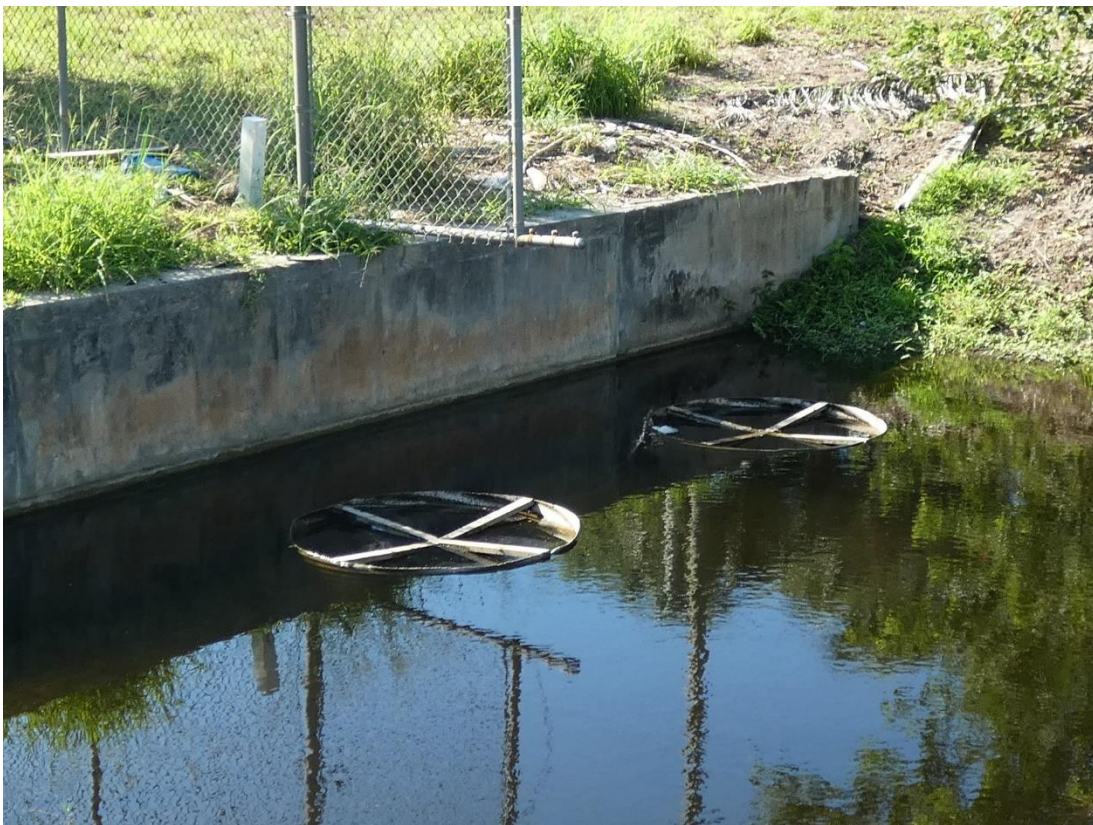
WATER CONTROL STRUCTURE #6

- ***Upstream Exterior Concrete Headwall*** appeared to be in moderate condition with moderate pop outs noted. the average pop out dimensions were 1/4 " in diameter and 1/8 " in depth? the total coverage of the pop out was an estimated at 15 %. there was no indication of cracking and loss in wall definition noted.

- **Downstream Exterior Concrete Headwall** appeared to be in moderate condition with moderate pop outs noted. the average pop out dimensions were $\frac{1}{4}$ " in diameter and $\frac{1}{8}$ " in depth? the total coverage of the pop out was an estimated at 15%. there was no indication of cracking and loss in wall definition noted.

- **Natural Bottom Report on the upstream side of both the Northern and Southern culvert risers** was reported as an organic/mud bottom on the upstream side with freeboard below the culvert riser opening to top of sediment ranging from 16" to 33" on both north and south.

- **Natural Bottom Report on the downstream side of both Northern and Southern culverts:** was reported as an organic/sand/mud bottom on the downstream side with <1 " to 2 " of freeboard below the culverts invert.

- **Sediment reported within both culverts** the diver reported minimal sediment within the two culverts.
